Access Compliance Report

Public Rights-of-Way

(Curb Ramps)

Intersection ID: 2516	Main Street: ROCKY_FORD_CLUB_RD	Cross Street: EASTFIELD_RD	Location: W
ADA ID: 9EAD879C271A	Ramp Type: Perp	Initial Pass/Fail: Fail	Overall Compliance: No
Severity Score: 8.75			
Codes/Mitigation Info/Possible Solution		Field Measurements/Component Compliance

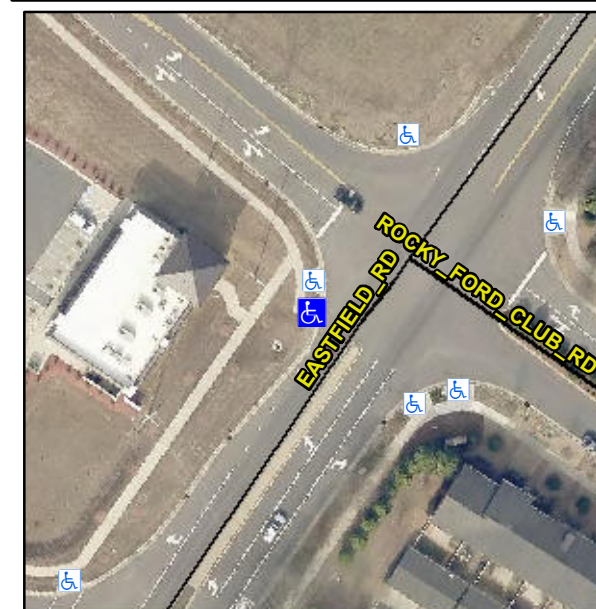
Compliance	Description	Data	Compliance	Description	Data
N/A	Ramp Length (in)	96.0	Yes	Ramp Slope (%)	6.9
No	Ramp Width (in)	47.0	Yes	Ramp XSlope (%)	0.3
N/A	Flare Type LT	N/A	N/A	Flare Type RT	N/A
N/A	Flare Slope LT (%)	N/A	N/A	Flare Slope RT (%)	N/A
N/A	Flare Traversable LT?	N/A	N/A	Flare Traversable RT?	N/A
N/A	Landing Length (in)	N/A	N/A	DWS Provided?	N/A
N/A	Landing Width (in)	N/A	N/A	DWS Contrast?	N/A
N/A	Landing Slope (%)	N/A	N/A	DWS Length (in)	N/A
N/A	Landing X Slope (%)	N/A	N/A	DWS Full Width?	N/A
N/A	Landing Curb? (Y/N)	N/A	N/A	DWS Offset (in)	N/A
N/A	Shared Landing?	N/A			
N/A	Gutter Ponding?	Yes	N/A	Gutter Slope (%)	N/A
N/A	Gutter Lip Ht (in)	N/A	N/A	Gutter X Slope (%)	N/A
N/A	Painted X Walk1?	No	N/A	Painted X Walk2?	N/A
	X Walk 1 Direction	To SE		X Walk 2 Direction	N/A
N/A	X Walk 1 Width (in)	N/A	N/A	X Walk 2 Width (in)	N/A
	X Walk 1 Slope (%)	1.7		X Walk 2 Slope (%)	N/A
	X Walk 1 X Slope (%)	2.0		X Walk 2 X Slope (%)	N/A

N/A	Ramp inside XWalk1?	N/A	N/A	Ramp inside XWalk2?	N/A
	Road Slope (%)	N/A	N/A	Clear Space?	N/A
	Road X Slope (%)	N/A	N/A	Clear Space to XWalk (in)	N/A
N/A	Any Obstructions?	N/A	N/A	Storm Grate/Utility Hazard?	N/A
	Obstruction Type			Storm Grate/Utility Type	
		N/A			N/A
		Yes		Surface Condition? (G/P)	Good

Possible Solutions:

Remove & Replace Entire Ramp.

R304.5.1
