# Access Compliance Report

## Public Rights-of-Way

### (Curb Ramps)

Intersection ID: 18483	Main Street: HOLLYDAY_CT	Cross Street: MURRAYHILL_RD	Location: NW
ADA ID: 9EB25DD6A1AF	Ramp Type: Directional1	Initial Pass/Fail: Fail	Overall Compliance: No
			Severity Score: 13.75

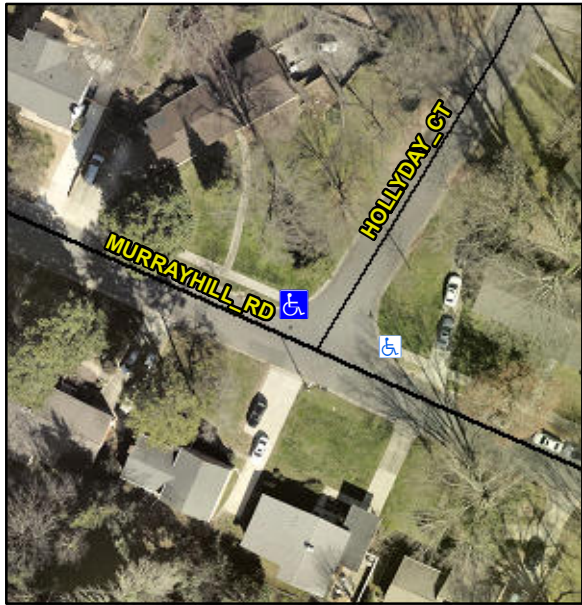
Possible Solutions:	Compliance			Description			Data	Compliance			Description			Data			
	Remove & Replace Entire Ramp.	N/A	Ramp Length (in)	74.0	N/A	Grade Break?	N/A	N/A	Grade Break Slope (%)	0.0	N/A	Grade Break XSlope (%)	0.0					
		Yes	Ramp Width (in)	57.0	N/A	Flare Type LT	N/A	N/A	Flare Slope LT (%)	N/A	N/A	Flare Type RT	N/A	N/A	Flare Slope RT (%)	0.0		
		No	Ramp Slope (%)	10.7	N/A	Flare Traversable LT?	N/A	N/A	Flare Traversable RT?	N/A	N/A	DWS Provided?	N/A	N/A	DWS Contrast?	N/A		
		No	Ramp XSlope (%)	2.3	N/A	Landing Length (in)	0.0	N/A	Landing Width (in)	0.0	N/A	Landing Slope (%)	0.0	N/A	Landing X Slope (%)	0.0		
	Surveyor Notes:	N/A	N/A	Landing X Slope (%)	0.0	N/A	Landing Curb? (Y/N)	N/A	N/A	Shared Landing?	N/A	N/A	DWS Offset LT (in)	N/A	N/A	DWS Offset RT (in)	N/A	
		PROW/ADA:	R304.2.2, R304.5.3	N/A	Gutter Ponding?	0.0	N/A	Gutter Lip Ht (in)	0.0	N/A	Painted X Walk1?	No	N/A	Road Slope (%)	2.6	N/A	Road X Slope (%)	5.5

X Walk 1 Direction	To E	N/A	X Walk 1 Width (in)	N/A	N/A	Clear Space?	N/A	N/A	Clear Space to XWalk (in)	N/A	N/A	Storm Grate/Utility Hazard?	N/A	
				X Walk 1 Slope (%)	2.6	N/A	X Walk 1 X Slope (%)	5.5	N/A	Storm Grate/Utility Type		N/A	Storm Grate/Utility Type		N/A			
			Ramp inside XWalk1?	N/A	N/A	Any Obstructions?	N/A	N/A	Obstruction Type		Yes	Surface Condition? (G/P)	Good	N/A	Curb Slope (%)	8.2		
Total Cost:		\$	1600.00
