# Access Compliance Report

## Public Rights-of-Way

### (Curb Ramps)

Intersection ID: 19925	Main Street: FAIRVIEW_RD	Cross Street: PROVIDENCE_RD	Location: W
ADA ID: 9EB5693978BE	Ramp Type: PerpDiag	Initial Pass/Fail: Fail	Overall Compliance: No
Severity Score: 12.5			
Codes/Mitigation Info/Possible Solution		Field Measurements/Component Compliance

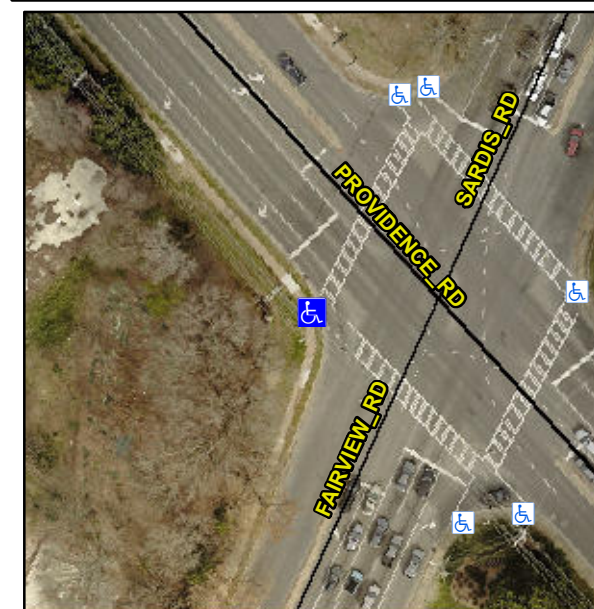
**Not Found, R304.2.2**

Compliance	Description	Data	Compliance	Description	Data
N/A	Ramp Length (in)	49.0	No	Ramp Slope (%)	10.0
Yes	Ramp Width (in)	48.0	Yes	Ramp XSlope (%)	0.5
N/A	Flare Type LT	N/A	N/A	Flare Type RT	N/A
N/A	Flare Slope LT (%)	N/A	N/A	Flare Slope RT (%)	N/A
N/A	Flare Traversable LT?	N/A	N/A	Flare Traversable RT?	N/A
N/A	Landing Length (in)	N/A	N/A	DWS Provided?	N/A
N/A	Landing Width (in)	N/A	N/A	DWS Contrast?	N/A
N/A	Landing Slope (%)	N/A	N/A	DWS Length (in)	N/A
N/A	Landing X Slope (%)	N/A	N/A	DWS Full Width?	N/A
N/A	Landing Curb? (Y/N)	N/A	N/A	DWS Offset (in)	N/A
N/A	Shared Landing?	N/A			
N/A	Gutter Ponding?	N/A	N/A	Gutter Slope (%)	N/A
N/A	Gutter Lip Ht (in)	N/A	N/A	Gutter X Slope (%)	N/A
N/A	Painted X Walk1?	Yes	N/A	Painted X Walk2?	Yes
	X Walk 1 Direction	To SE		X Walk 2 Direction	To NE
N/A	X Walk 1 Width (in)	106.0	N/A	X Walk 2 Width (in)	86.0
	X Walk 1 Slope (%)	2.3		X Walk 2 Slope (%)	0.3
	X Walk 1 X Slope (%)	0.3		X Walk 2 X Slope (%)	1.8

N/A	Ramp inside XWalk1?	Yes	N/A	Ramp inside XWalk2?	Yes
	Road Slope (%)	0.1	N/A	Clear Space?	N/A
	Road X Slope (%)	1.0	N/A	Clear Space to XWalk (in)	N/A
N/A	Any Obstructions?	N/A	N/A	Storm Grate/Utility Hazard?	N/A
	Obstruction Type			Storm Grate/Utility Type	
		N/A			N/A
		Yes		Surface Condition? (G/P)	Good

**Remove & Replace Curb Ramp With Two New Directional Ramps or Equivalent.**

Total Cost: \$ 3200.00
