Access Compliance Report Public Rights-of-Way (Curb Ramps)

Intersection ID: 12265 Main Street: S CHURCH ST Cross Street: W_4TH_ST Location:

ADA ID: 9EC0C0E464AD Ramp Type: PerpDiag Initial Pass/Fail: Fail **Overall Compliance: No** Severity Score: 21.25

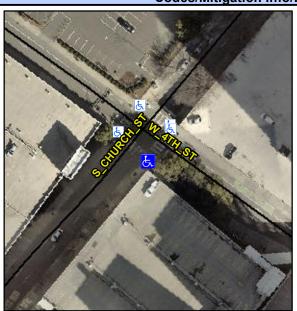
ried measurements/component compnance						
Compliance Description		Data	Compliance Description		Data	
N/A	Ramp Length (in)	70.0	No	Ramp Slope (%)	10.6	
No	Ramp Width (in)	39.0	Yes	Ramp XSlope (%)	0.2	
N/A	Flare Type LT	N/A	N/A	Flare Type RT	N/A	
N/A	Flare Slope LT (%)	N/A	N/A	Flare Slope RT (%)	N/A	
N/A	Flare Traversable LT?	N/A	N/A	Flare Traversable RT?	N/A	
N/A	Landing Length (in)	N/A	N/A	DWS Provided?	N/A	
N/A	Landing Width (in)	N/A	N/A	DWS Contrast?	N/A	
N/A	Landing Slope (%)	N/A	N/A	DWS Length (in)	N/A	
N/A	Landing X Slope (%)	N/A	N/A	DWS Full Width?	N/A	
N/A	Landing Curb? (Y/N)	N/A	N/A	DWS Offset (in)	N/A	
N/A	Shared Landing?	N/A				
N/A	Gutter Ponding?	N/A	N/A	Gutter Slope (%)	N/A	
N/A	Gutter Lip Ht (in)	N/A	N/A	Gutter X Slope (%)	N/A	
N/A	Painted X Walk1?	Yes	N/A	Painted X Walk2?	Yes	
	X Walk 1 Direction	To NE		X Walk 2 Direction	To NW	
N/A	X Walk 1 Width (in)	114.0	N/A	X Walk 2 Width (in)	113.0

X Walk 1 Slope (%)	4.9		X Walk 2 Slope (%)	0.8	
	X Walk 1 X Slope (%)	0.0		X Walk 2 X Slope (%)	2.9	
N/A	Ramp inside XWalk1?	Yes	N/A	Ramp inside XWalk2?	Yes	
	Road Slope (%)	0.4	N/A	Clear Space?	N/A	
	Road X Slope (%)	3.1	N/A	Clear Space to XWalk (in)	N/A	
N/A	Any Obstructions?	N/A	N/A	Storm Grate/Utility Hazard?	N/A

W 4TH ST Signal **S CHURCH ST** Signal Possible Solutions: Remove & Replace Curb Ramp With Two New Directional Ramps or Equivalent. Surveyor Notes: N/A PROW/ADA: Not Found, R304.5.1, R304.2.2

Total Cost: 3200.00
