Access Compliance Report

Public Rights-of-Way

(Curb Ramps)

Intersection ID: 2990	Main Street: THOMAS_RIDGE_DR	Cross Street: PROSPERITY_RIDGE_RD	Location: SE
ADA ID: 9EC795B9F998	Ramp Type: PerpDiag	Initial Pass/Fail: Fail	Overall Compliance: No
Severity Score: 21.25			
Codes/Mitigation Info/Possible Solution		Field Measurements/Component Compliance

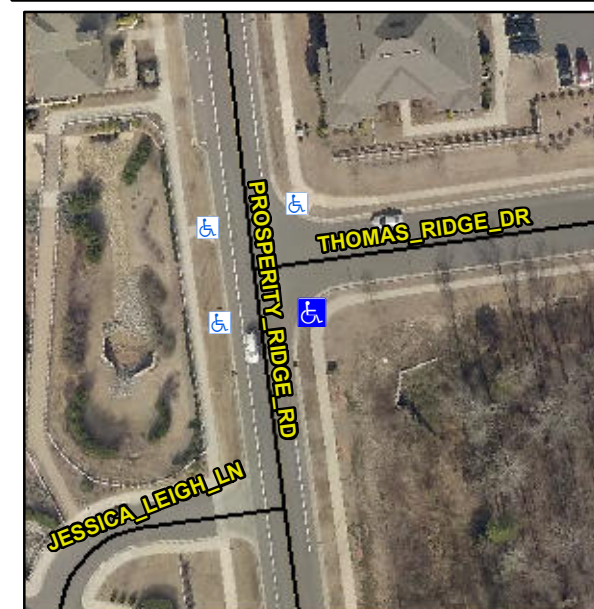
Compliance	Description	Data	Compliance	Description	Data
N/A	Ramp Length (in)	55.5	Yes	Ramp Slope (%)	6.3
No	Ramp Width (in)	47.5	No	Ramp XSlope (%)	5.1
N/A	Flare Type LT	N/A	N/A	Flare Type RT	N/A
N/A	Flare Slope LT (%)	N/A	N/A	Flare Slope RT (%)	N/A
N/A	Flare Traversable LT?	N/A	N/A	Flare Traversable RT?	N/A
N/A	Landing Length (in)	N/A	N/A	DWS Provided?	N/A
N/A	Landing Width (in)	N/A	N/A	DWS Contrast?	N/A
N/A	Landing Slope (%)	N/A	N/A	DWS Length (in)	N/A
N/A	Landing X Slope (%)	N/A	N/A	DWS Full Width?	N/A
N/A	Landing Curb? (Y/N)	N/A	N/A	DWS Offset (in)	N/A
N/A	Shared Landing?	N/A			
N/A	Gutter Ponding?	N/A	N/A	Gutter Slope (%)	N/A
N/A	Gutter Lip Ht (in)	N/A	N/A	Gutter X Slope (%)	N/A
N/A	Painted X Walk1?	No	N/A	Painted X Walk2?	No
	X Walk 1 Direction	To N		X Walk 2 Direction	To W
N/A	X Walk 1 Width (in)	N/A	N/A	X Walk 2 Width (in)	N/A
	X Walk 1 Slope (%)	0.2		X Walk 2 Slope (%)	6.7
	X Walk 1 X Slope (%)	9.3		X Walk 2 X Slope (%)	0.5

N/A	Ramp inside XWalk1?	N/A	N/A	Ramp inside XWalk2?	N/A
	Road Slope (%)	6.1	N/A	Clear Space?	N/A
	Road X Slope (%)	3.7	N/A	Clear Space to XWalk (in)	N/A
N/A	Any Obstructions?	N/A	N/A	Storm Grate/Utility Hazard?	N/A
	Obstruction Type			Storm Grate/Utility Type	
		N/A			N/A
		Yes		Surface Condition? (G/P)	Good

Possible Solutions:

Remove & Replace Curb Ramp With Two New Directional Ramps or Equivalent.
