Access Compliance Report

Public Rights-of-Way

(Curb Ramps)

Intersection ID: 4199	Main Street: OLD_STATESVILLE_RD	Cross Street: W_W_T_HARRIS_BV	Location: SE
ADA ID: 9ECB587434B6	Ramp Type: Perp	Initial Pass/Fail: Fail	Overall Compliance: No
		Severity Score: 30

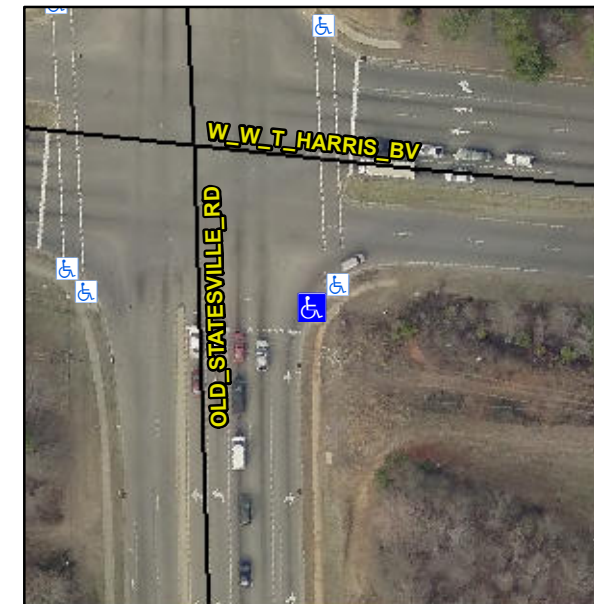
R304.5.1, R304.2.2

Compliance	Description	Data	Compliance	Description	Data
N/A	Ramp Length (in)	60.0	No	Ramp Slope (%)	11.7
No	Ramp Width (in)	34.0	Yes	Ramp XSlope (%)	0.5
N/A	Flare Type LT	N/A	N/A	Flare Type RT	N/A
N/A	Flare Slope LT (%)	N/A	N/A	Flare Slope RT (%)	N/A
N/A	Flare Traversable LT?	N/A	N/A	Flare Traversable RT?	N/A
N/A	Landing Length (in)	N/A	N/A	DWS Provided?	N/A
N/A	Landing Width (in)	N/A	N/A	DWS Contrast?	N/A
N/A	Landing Slope (%)	N/A	N/A	DWS Length (in)	N/A
N/A	Landing X Slope (%)	N/A	N/A	DWS Full Width?	N/A
N/A	Landing Curb? (Y/N)	N/A	N/A	DWS Offset (in)	N/A
N/A	Shared Landing?	N/A			
N/A	Gutter Ponding?	N/A	N/A	Gutter Slope (%)	N/A
N/A	Gutter Lip Ht (in)	N/A	N/A	Gutter X Slope (%)	N/A
N/A	Painted X Walk1?	Yes	N/A	Painted X Walk2?	N/A
	X Walk 1 Direction	To NW		X Walk 2 Direction	N/A
N/A	X Walk 1 Width (in)	98.0	N/A	X Walk 2 Width (in)	N/A
	X Walk 1 Slope (%)	1.2		X Walk 2 Slope (%)	N/A
	X Walk 1 X Slope (%)	0.6		X Walk 2 X Slope (%)	N/A

N/A	Ramp inside XWalk1?	Yes	N/A	Ramp inside XWalk2?	N/A
	Road Slope (%)	N/A	N/A	Clear Space?	N/A
	Road X Slope (%)	N/A	N/A	Clear Space to XWalk (in)	N/A
N/A	Any Obstructions?	N/A	N/A	Storm Grate/Utility Hazard?	N/A
	Obstruction Type			Storm Grate/Utility Type	
		N/A			N/A
			Yes	Surface Condition? (G/P)	Good

Possible Solutions:

Remove & Replace Entire Ramp.

Total Cost: \$ 1850.00
