## **Access Compliance Report Public Rights-of-Way** (Curb Ramps)

Intersection ID: 10019990 Main Street: ARMORY DR **Cross Street: N/A** Location: NE ADA ID: 9EDB19FF33B6 Ramp Type: PerpDiag Initial Pass/Fail: Fail **Overall Compliance: No** Severity Score: 13.75

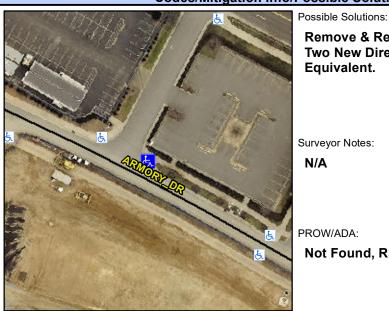
Not Found, R304.2.2, R304.5.3

Comp	liance Description	Data	Compliance		Description	Data
N/A	Ramp Length (in)	55.0	No	Ramp	Slope (%)	10.0
Yes	Ramp Width (in)	48.0	No	Ramp	XSlope (%)	3.5
N/A	Flare Type LT	N/A	N/A	Flare	Type RT	N/A
N/A	Flare Slope LT (%)	N/A	N/A	Flare	Slope RT (%)	N/A
N/A	Flare Traversable LT?	N/A	N/A	Flare	Traversable RT?	N/A
N/A	Landing Length (in)	N/A	N/A	DWS	Provided?	N/A
N/A	Landing Width (in)	N/A	N/A	DWS	Contrast?	N/A
N/A	Landing Slope (%)	N/A	N/A	DWS	Length (in)	N/A
N/A	Landing X Slope (%)	N/A	N/A	DWS	Full Width?	N/A
N/A	Landing Curb? (Y/N)	N/A	N/A	DWS	Offset (in)	N/A
N/A	Shared Landing?	N/A				
N/A	Gutter Ponding?	N/A	N/A	Gutter	Slope (%)	N/A
N/A	Gutter Lip Ht (in)	N/A	N/A	Gutter	X Slope (%)	N/A
N/A	Painted X Walk1?	No	N/A	Painte	ed X Walk2?	No
	X Walk 1 Direction	To NW		X Wal	k 2 Direction	To SW
N/A	X Walk 1 Width (in)	N/A	N/A	X Wal	k 2 Width (in)	N/A
	X Walk 1 Slope (%)	2.2		X Wal	k 2 Slope (%)	3.7
	X Walk 1 X Slope (%)	6.2		X Wal	k 2 X Slope (%)	0.3

N/A	Ramp inside XWalk1?	N/A	N/A	Ramp	inside XWalk2?	N/A
	Road Slope (%)	3.3	N/A	Clear	Space?	N/A
	Road X Slope (%)	4.2	N/A	Clear	Space to XWalk (in)	N/A
N/A	Any Obstructions?	N/A	N/A	Storm	Grate/Utility Hazard?	N/A
	Obstruction Type			Storm	Grate/Utility Type	
		N/A				N/A

Remove & Replace Curb Ramp With Two New Directional Ramps or Equivalent.
