Access Compliance Report

Public Rights-of-Way

(Curb Ramps)

Intersection ID: 23633	Main Street: LARRISA_CT	Cross Street: HILLSIDE_LN	Location: NE
ADA ID: 9EE228AD7568	Ramp Type: Perp	Initial Pass/Fail: Fail	Overall Compliance: No
		Severity Score: 8.75

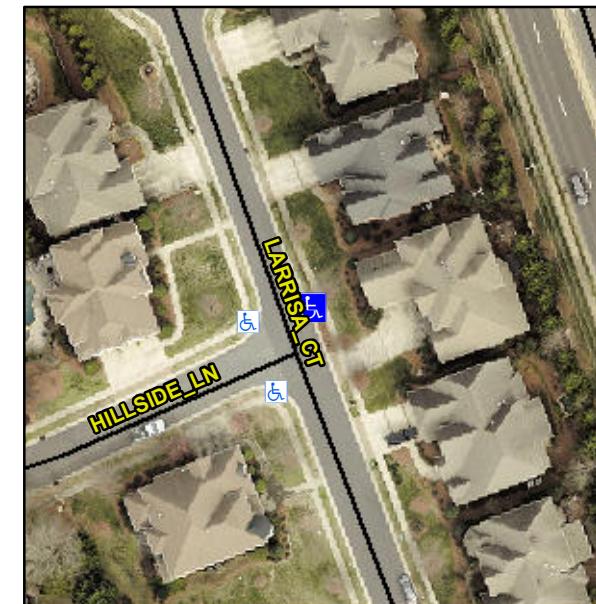
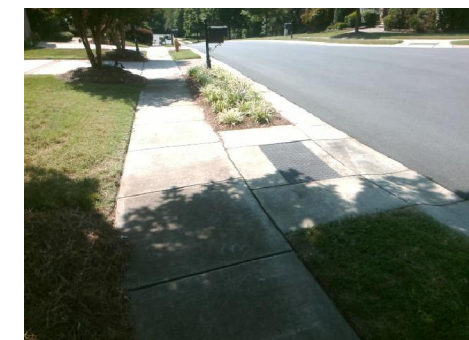
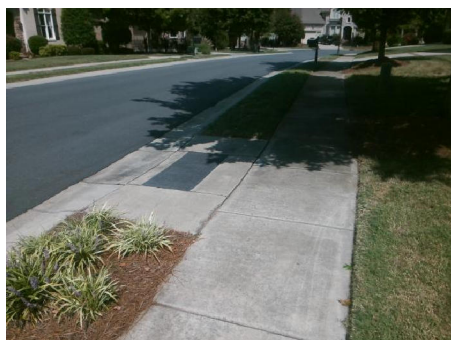
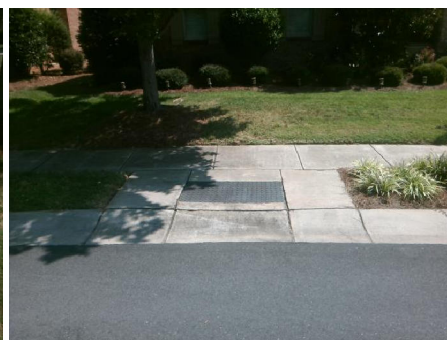
Not Found, R304.5.1

Compliance	Description	Data	Compliance	Description	Data
N/A	Ramp Length (in)	47.0	Yes	Ramp Slope (%)	6.5
No	Ramp Width (in)	47.0	Yes	Ramp XSlope (%)	0.9
N/A	Flare Type LT	N/A	N/A	Flare Type RT	N/A
N/A	Flare Slope LT (%)	N/A	N/A	Flare Slope RT (%)	N/A
N/A	Flare Traversable LT?	N/A	N/A	Flare Traversable RT?	N/A
N/A	Landing Length (in)	N/A	N/A	DWS Provided?	N/A
N/A	Landing Width (in)	N/A	N/A	DWS Contrast?	N/A
N/A	Landing Slope (%)	N/A	N/A	DWS Length (in)	N/A
N/A	Landing X Slope (%)	N/A	N/A	DWS Full Width?	N/A
N/A	Landing Curb? (Y/N)	N/A	N/A	DWS Offset (in)	N/A
N/A	Shared Landing?	N/A			
N/A	Gutter Ponding?	N/A	N/A	Gutter Slope (%)	N/A
N/A	Gutter Lip Ht (in)	N/A	N/A	Gutter X Slope (%)	N/A
N/A	Painted X Walk1?	No	N/A	Painted X Walk2?	N/A
	X Walk 1 Direction	To W		X Walk 2 Direction	N/A
N/A	X Walk 1 Width (in)	N/A	N/A	X Walk 2 Width (in)	N/A
	X Walk 1 Slope (%)	5.2		X Walk 2 Slope (%)	N/A
	X Walk 1 X Slope (%)	0.1		X Walk 2 X Slope (%)	N/A

N/A	Ramp inside XWalk1?	N/A	N/A	Ramp inside XWalk2?	N/A
	Road Slope (%)	N/A	N/A	Clear Space?	N/A
	Road X Slope (%)	N/A	N/A	Clear Space to XWalk (in)	N/A
N/A	Any Obstructions?	N/A	N/A	Storm Grate/Utility Hazard?	N/A
	Obstruction Type			Storm Grate/Utility Type	
		N/A			N/A
			Yes	Surface Condition? (G/P)	Good

Remove & Replace Entire Ramp.
