# Access Compliance Report

## Public Rights-of-Way

### (Curb Ramps)

Intersection ID: 11981	Main Street: W_6TH_ST	Cross Street: N_CHURCH_ST	Location: E
ADA ID: 9EE7B8937E5B	Ramp Type: PerpDiag	Initial Pass/Fail: Fail	Overall Compliance: No
Severity Score: 48.75			
Codes/Mitigation Info/Possible Solution		Field Measurements/Component Compliance

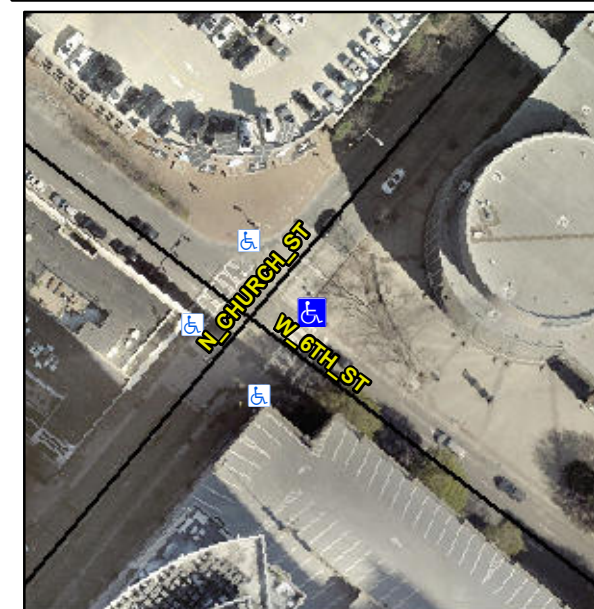
**Not Found, R304.5.1, R304.2.2, R304.5.3**

Compliance	Description	Data	Compliance	Description	Data
N/A	Ramp Length (in)	35.0	No	Ramp Slope (%)	10.1
No	Ramp Width (in)	31.0	No	Ramp XSlope (%)	3.6
N/A	Flare Type LT	N/A	N/A	Flare Type RT	N/A
N/A	Flare Slope LT (%)	N/A	N/A	Flare Slope RT (%)	N/A
N/A	Flare Traversable LT?	N/A	N/A	Flare Traversable RT?	N/A
N/A	Landing Length (in)	N/A	N/A	DWS Provided?	N/A
N/A	Landing Width (in)	N/A	N/A	DWS Contrast?	N/A
N/A	Landing Slope (%)	N/A	N/A	DWS Length (in)	N/A
N/A	Landing X Slope (%)	N/A	N/A	DWS Full Width?	N/A
N/A	Landing Curb? (Y/N)	N/A	N/A	DWS Offset (in)	N/A
N/A	Shared Landing?	N/A			
N/A	Gutter Ponding?	N/A	N/A	Gutter Slope (%)	N/A
N/A	Gutter Lip Ht (in)	N/A	N/A	Gutter X Slope (%)	N/A
N/A	Painted X Walk1?	Yes	N/A	Painted X Walk2?	Yes
	X Walk 1 Direction	To NW		X Walk 2 Direction	To SW
N/A	X Walk 1 Width (in)	114.0	N/A	X Walk 2 Width (in)	112.0
	X Walk 1 Slope (%)	0.4		X Walk 2 Slope (%)	0.1
	X Walk 1 X Slope (%)	2.0		X Walk 2 X Slope (%)	1.9

N/A	Ramp inside XWalk1?	Yes	N/A	Ramp inside XWalk2?	Yes
	Road Slope (%)	0.7	N/A	Clear Space?	N/A
	Road X Slope (%)	0.5	N/A	Clear Space to XWalk (in)	N/A
N/A	Any Obstructions?	N/A	N/A	Storm Grate/Utility Hazard?	N/A
	Obstruction Type			Storm Grate/Utility Type	
		N/A			N/A
		Yes		Surface Condition? (G/P)	Good

**Remove & Replace Curb Ramp With Two New Directional Ramps or Equivalent.**
