Access Compliance Report

Public Rights-of-Way (Curb Ramps)

Intersection ID: 50339	Main Street: CASTLECOVE_RD	Cross Street: PAISLEY_ABBEY_LN	Location: SE
ADA ID: 9EECEBF9C3FC	Ramp Type: Perp	Initial Pass/Fail: Fail	Overall Compliance: No
		Severity Score: 12.5

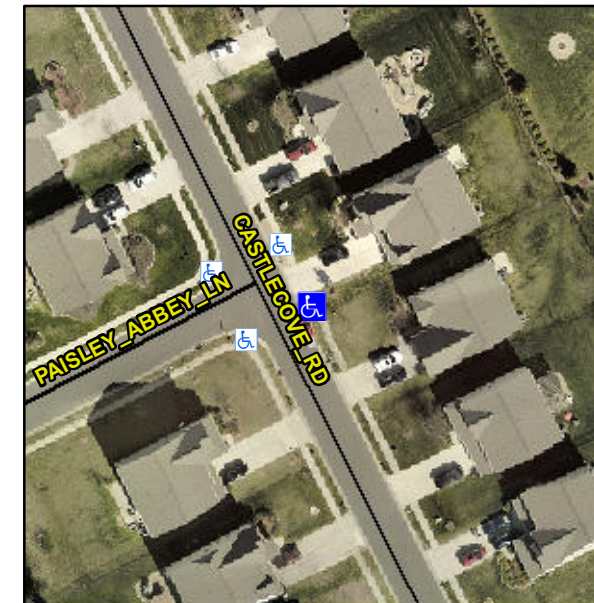
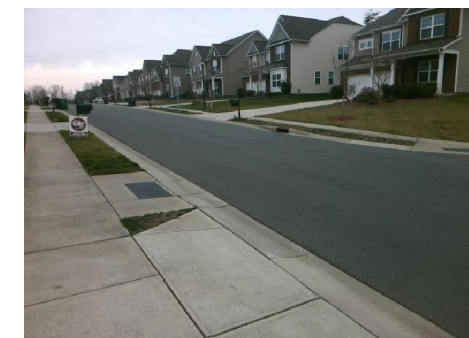
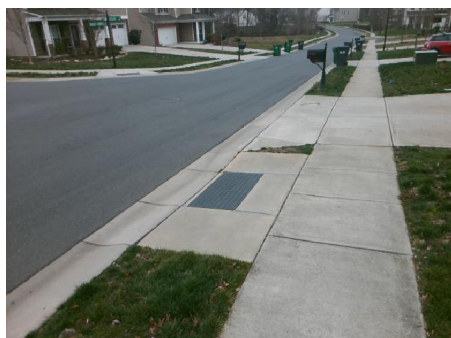
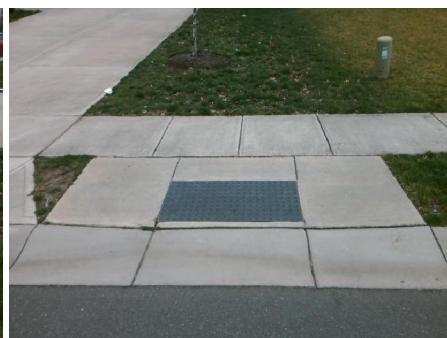
Not Found, R304.5.3

Compliance	Description	Data	Compliance	Description	Data
N/A	Ramp Length (in)	45.0	Yes	Ramp Slope (%)	6.0
Yes	Ramp Width (in)	48.0	No	Ramp XSlope (%)	5.3
N/A	Flare Type LT	N/A	N/A	Flare Type RT	N/A
N/A	Flare Slope LT (%)	N/A	N/A	Flare Slope RT (%)	N/A
N/A	Flare Traversable LT?	N/A	N/A	Flare Traversable RT?	N/A
N/A	Landing Length (in)	N/A	N/A	DWS Provided?	N/A
N/A	Landing Width (in)	N/A	N/A	DWS Contrast?	N/A
N/A	Landing Slope (%)	N/A	N/A	DWS Length (in)	N/A
N/A	Landing X Slope (%)	N/A	N/A	DWS Full Width?	N/A
N/A	Landing Curb? (Y/N)	N/A	N/A	DWS Offset (in)	N/A
N/A	Shared Landing?	N/A			
N/A	Gutter Ponding?	N/A	N/A	Gutter Slope (%)	N/A
N/A	Gutter Lip Ht (in)	N/A	N/A	Gutter X Slope (%)	N/A
N/A	Painted X Walk1?	No	N/A	Painted X Walk2?	N/A
	X Walk 1 Direction	To SW		X Walk 2 Direction	N/A
N/A	X Walk 1 Width (in)	N/A	N/A	X Walk 2 Width (in)	N/A
	X Walk 1 Slope (%)	2.8		X Walk 2 Slope (%)	N/A
	X Walk 1 X Slope (%)	4.9		X Walk 2 X Slope (%)	N/A

N/A	Ramp inside XWalk1?	N/A	N/A	Ramp inside XWalk2?	N/A
	Road Slope (%)	N/A	N/A	Clear Space?	N/A
	Road X Slope (%)	N/A	N/A	Clear Space to XWalk (in)	N/A
N/A	Any Obstructions?	N/A	N/A	Storm Grate/Utility Hazard?	N/A
	Obstruction Type			Storm Grate/Utility Type	
		N/A			N/A
			Yes	Surface Condition? (G/P)	Good

Remove & Replace Entire Ramp.
