# Access Compliance Report

## Public Rights-of-Way

### (Curb Ramps)

Intersection ID: 11171	Main Street: ARIA_CT	Cross Street: AVENTIDE_LN	Location:	SE
ADA ID: 9EEE7FEB0F00	Ramp Type: BlendTrans1	Initial Pass/Fail: Fail	Overall Compliance: No	Severity Score: 10
Codes/Mitigation Info/Possible Solution		Field Measurements/Component Compliance

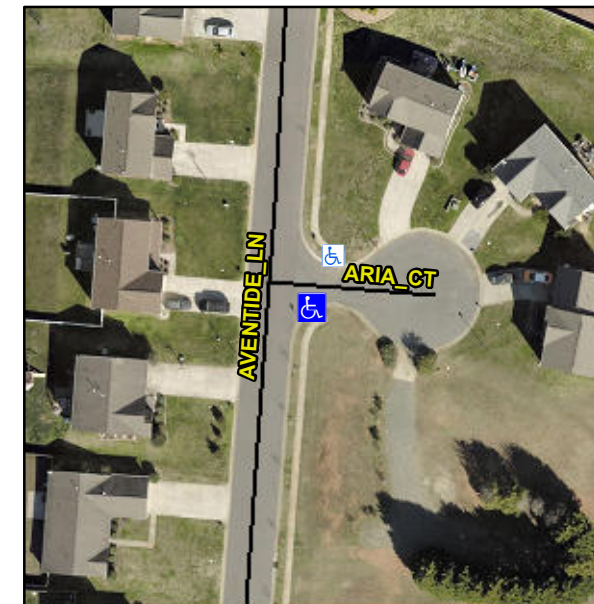
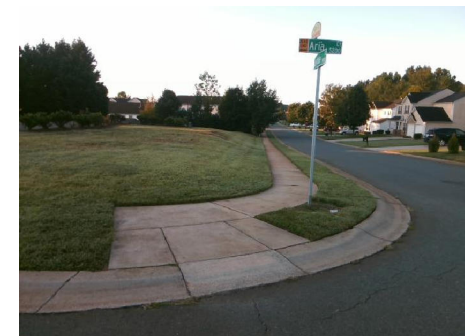
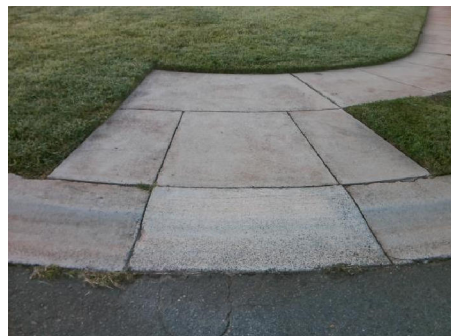
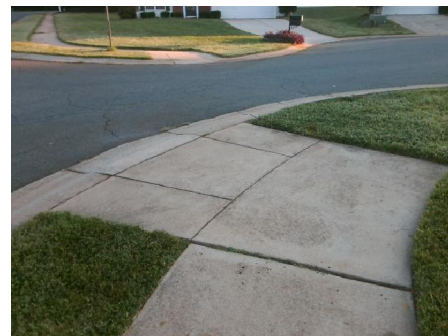
**NO LT SW**

**Not Found, R304.5.1, R304.5.3**

Compliance	Description	Data	Compliance	Description	Data
N/A	Ramp Length (in)	47.0	Yes	BlendTrans Slope (%)	3.0
No	Ramp Width (in)	37.5	No	BlendTrans XSlope (%)	4.5
N/A	Flare Type LT	N/A	N/A	Flare Type RT	N/A
N/A	Flare Slope LT (%)	N/A	N/A	Flare Slope RT (%)	N/A
N/A	Flare Traversable LT?	N/A	N/A	Flare Traversable RT?	N/A
N/A	Landing Length (in)	N/A	N/A	DWS Provided?	N/A
N/A	Landing Width (in)	N/A	N/A	DWS Contrast?	N/A
N/A	Landing Slope (%)	N/A	N/A	DWS Length (in)	N/A
N/A	Landing X Slope (%)	N/A	N/A	DWS Full Width?	N/A
N/A	Landing Curb? (Y/N)	N/A	N/A	DWS Offset (in)	N/A
N/A	Shared Landing?	N/A			
N/A	Gutter Ponding?	N/A	N/A	Gutter Slope (%)	N/A
N/A	Gutter Lip Ht (in)	1.0	N/A	Gutter X Slope (%)	N/A
N/A	Painted X Walk1?	No	N/A	Painted X Walk2?	N/A
	X Walk 1 Direction	To N		X Walk 2 Direction	N/A
	X Walk 1 Width (in)	N/A		X Walk 2 Width (in)	N/A
	X Walk 1 Slope (%)	3.2		X Walk 2 Slope (%)	N/A
	X Walk 1 X Slope (%)	0.3		X Walk 2 X Slope (%)	N/A

N/A	Ramp inside XWalk1?	N/A	N/A	Ramp inside XWalk2?	N/A
	Road Slope (%)	0.3		Clear Space?	N/A
	Road X Slope (%)	3.2	N/A	Clear Space to XWalk (in)	N/A
N/A	Any Obstructions?	N/A	N/A	Storm Grate/Utility Hazard?	N/A
	Obstruction Type			Storm Grate/Utility Type	
		N/A			N/A
			Yes	Surface Condition? (G/P)	Good
			No	Curb Slope (%)	14.7

**Remove & Replace Curb Ramp With Two New Directional Ramps or Equivalent.**
