# Access Compliance Report

## Public Rights-of-Way (Curb Ramps)

| Intersection ID: N/A | Main Street: MARTIN_LUTHER_KING_JR_BV | Cross Street: N/A | Location: W |
| ADA ID: 9EF9449E20F2 | Ramp Type: BlendTrans1 | Initial Pass/Fail: Pass | Overall Compliance: No |

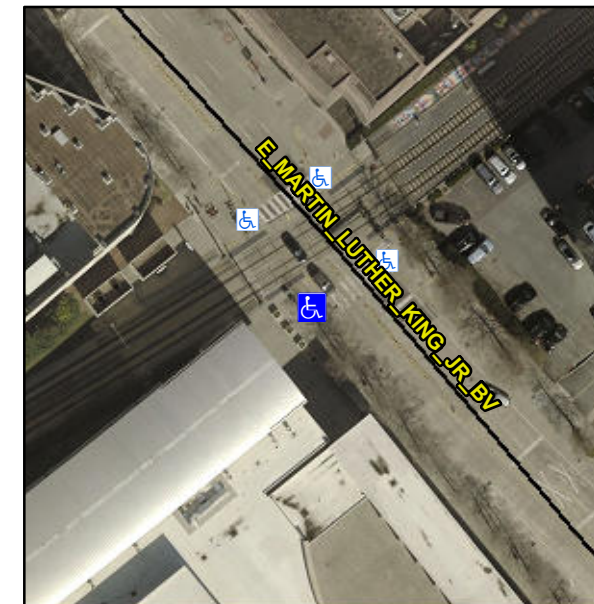
| Severity Score: 0.25 | | | |

| Compliance | Description | Data | Compliance | Description | Data |
|---|---|---|---|---|---|
| Yes | Ramp Width (in) | 48.0 | No | BlendTrans XSlope (%) | 2.2 |
| No | Landing X Slope (%) | 2.7 | Yes | DWS Full Width? | Yes |
| Yes | Gutter Lip Ht (in) | 0.0 | No | Gutter X Slope (%) | 2.8 |

**Remove & Replace Curb Ramp With Two New Directional Ramps or Equivalent. Remove & Replace Gutter.**

**R304.5.3**

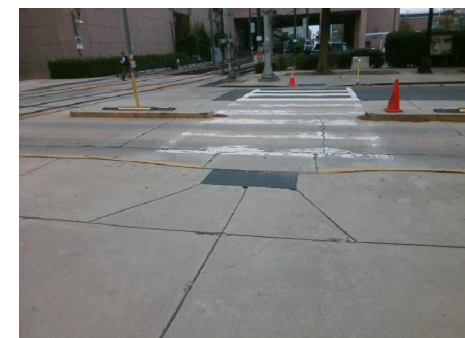
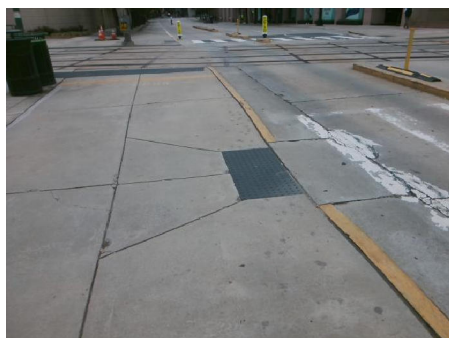
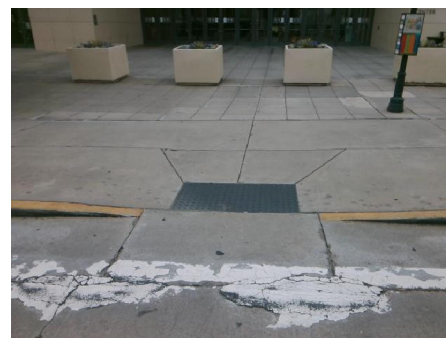
| Compliance | Description | Data | Compliance | Description | Data |
|---|---|---|---|---|---|
| | | | Yes | Surface Condition? (G/P) | Good |
