# Access Compliance Report

## Public Rights-of-Way

### (Curb Ramps)

| Intersection ID: 5595 | Main Street: CORNELIA_DR | Cross Street: STARMOUNT_AV | Location: S |

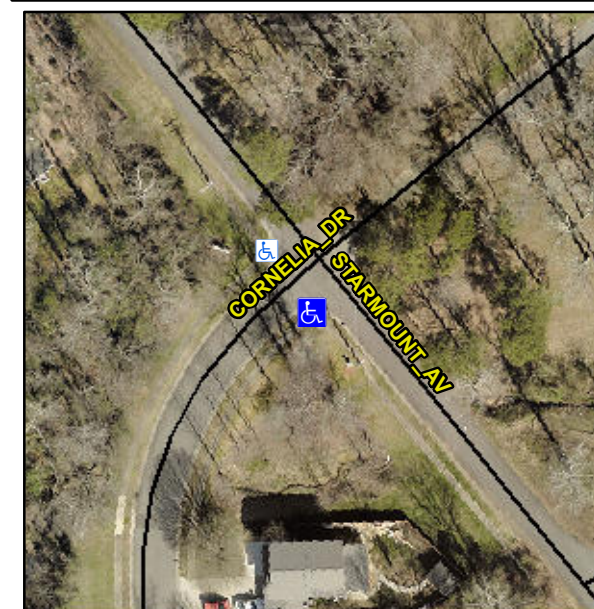
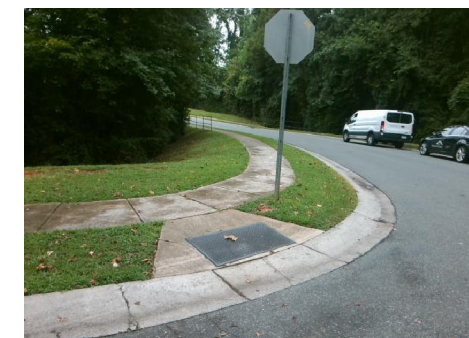
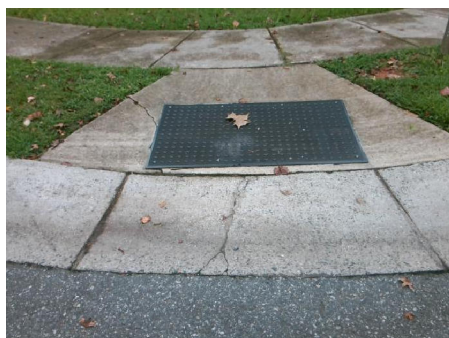
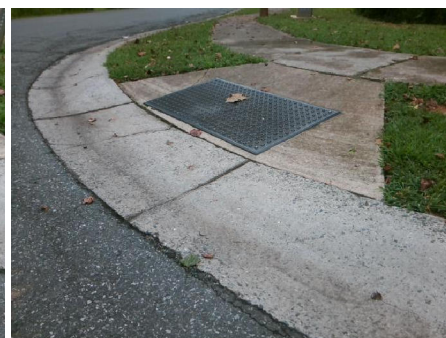
| ADA ID: 9F099811B22E | Ramp Type: Perp | Initial Pass/Fail: Fail | Overall Compliance: No |

**Not Found, R304.5.1, R304.2.2**

| Compliance | Description | Data | Compliance | Description | Data |
|---|---|---|---|---|---|
| N/A | Ramp Length (in) | 51.0 | No | Ramp Slope (%) | 11.0 |
| No | Ramp Width (in) | 42.5 | Yes | Ramp XSlope (%) | 0.8 |

**Remove & Replace Entire Ramp.**
