Access Compliance Report

Public Rights-of-Way

(Curb Ramps)

Intersection ID: 13568	Main Street: ARLINGTON_AV	Cross Street: SOUTH_BV	Location: NW
ADA ID: 9F09ABBE7279	Ramp Type: BlendTrans1	Initial Pass/Fail: Pass	Overall Compliance: No
		Severity Score: 10

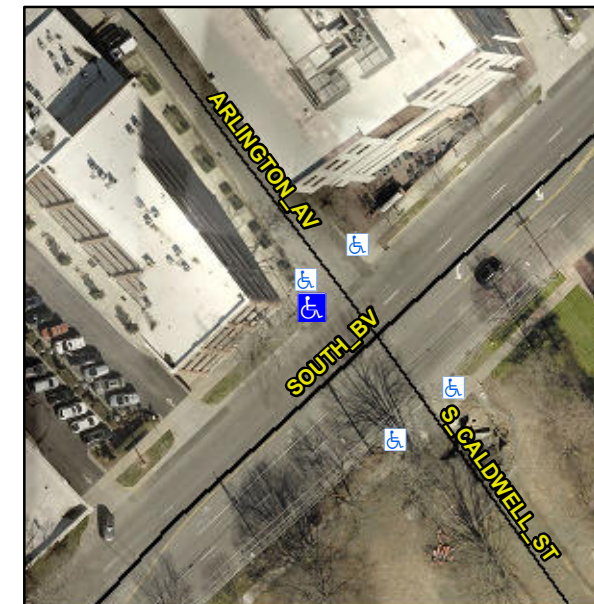
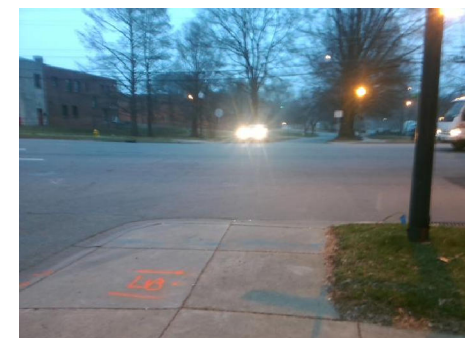
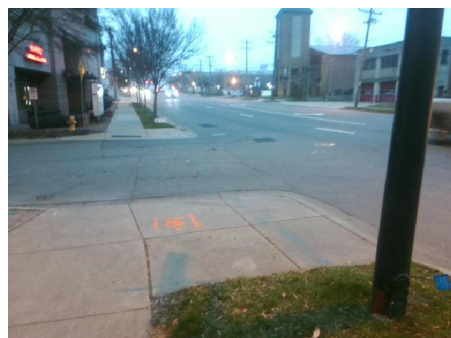
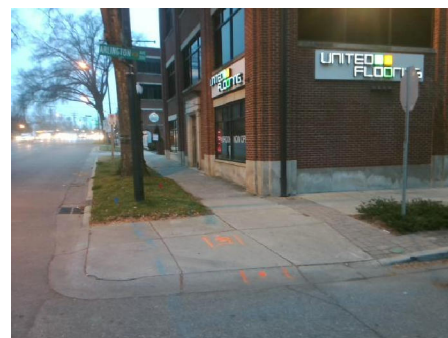
Compliance	Description	Data	Compliance	Description	Data
N/A	Ramp Length (in)	42.0	Yes	BlendTrans Slope (%)	1.5
Yes	Ramp Width (in)	60.0	Yes	BlendTrans XSlope (%)	0.2
N/A	Flare Type LT	None	N/A	Flare Type RT	Sloped
N/A	Flare Slope LT (%)	N/A	N/A	Flare Slope RT (%)	1.9
N/A	Flare Traversable LT?	N/A	N/A	Flare Traversable RT?	No
Yes	Landing Length (in)	54.0	No	DWS Provided?	No
Yes	Landing Width (in)	53.0	N/A	DWS Contrast?	No
Yes	Landing Slope (%)	1.6	N/A	DWS Length (in)	N/A
Yes	Landing X Slope (%)	1.1	N/A	DWS Full Width?	No
N/A	Landing Curb? (Y/N)	No	N/A	DWS Offset (in)	N/A
N/A	Shared Landing?	Yes			
Yes	Gutter Ponding?	No	Yes	Gutter Slope (%)	0.2
Yes	Gutter Lip Ht (in)	0.0	No	Gutter X Slope (%)	2.1
N/A	Painted X Walk1?	No	N/A	Painted X Walk2?	N/A
	X Walk 1 Direction	To SE		X Walk 2 Direction	N/A
	X Walk 1 Width (in)	N/A		X Walk 2 Width (in)	N/A
	X Walk 1 Slope (%)	5.5		X Walk 2 Slope (%)	N/A
	X Walk 1 X Slope (%)	0.3		X Walk 2 X Slope (%)	N/A

N/A	Ramp inside XWalk1?	N/A	N/A	Ramp inside XWalk2?	N/A
	Road Slope (%)	0.3		Clear Space?	Yes
	Road X Slope (%)	5.5	N/A	Clear Space to XWalk (in)	N/A
Yes	Any Obstructions?	No	Yes	Storm Grate/Utility Hazard?	No
	Obstruction Type			Storm Grate/Utility Type	
		N/A			N/A
			Yes	Surface Condition? (G/P)	Good
			No	Curb Slope (%)	22.1

Remove & Replace Curb Ramp With Two New Directional Ramps or Equivalent. Remove & Replace Gutter.
