# Access Compliance Report

## Public Rights-of-Way

### (Curb Ramps)

Intersection ID: N/A	Main Street: MONROE_RD	Cross Street: PRINCESS_ANN_DR	Location: W
ADA ID: 9F0A24E1026E	Ramp Type: PerpDiag	Initial Pass/Fail: Fail	Overall Compliance: No
Severity Score: 12.5			
Codes/Mitigation Info/Possible Solution		Field Measurements/Component Compliance

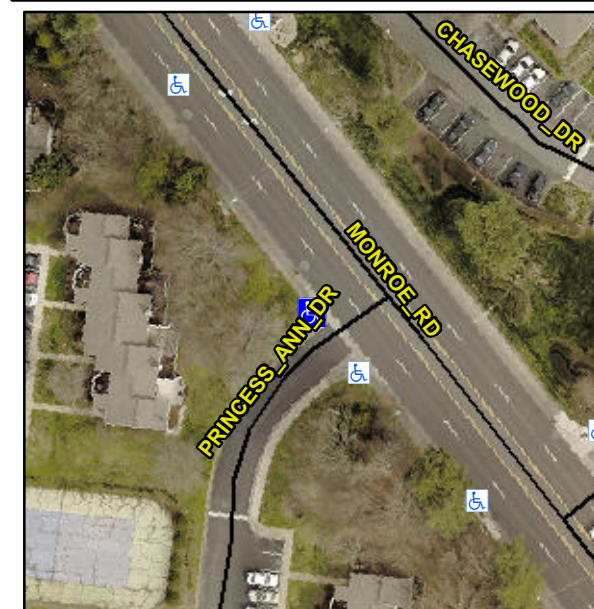
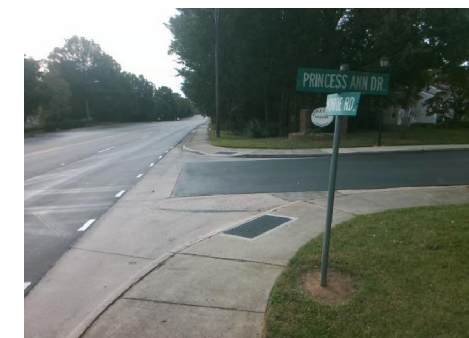
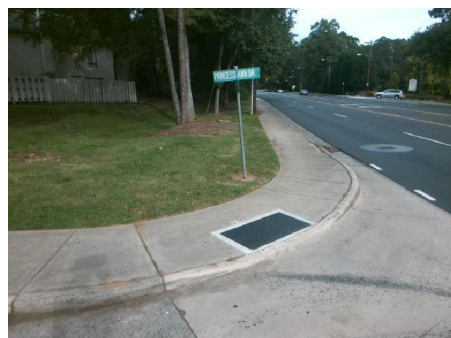
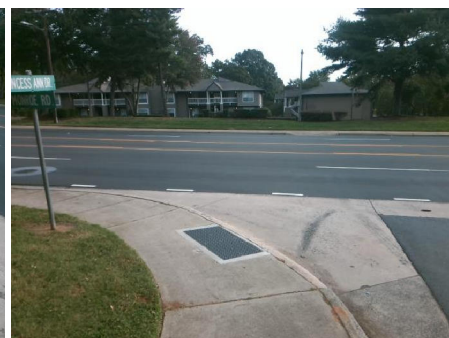
**Not Found, R304.2.2**

Compliance	Description	Data	Compliance	Description	Data
N/A	Ramp Length (in)	60.0	No	Ramp Slope (%)	8.7
Yes	Ramp Width (in)	48.0	Yes	Ramp XSlope (%)	0.8
N/A	Flare Type LT	N/A	N/A	Flare Type RT	N/A
N/A	Flare Slope LT (%)	N/A	N/A	Flare Slope RT (%)	N/A
N/A	Flare Traversable LT?	N/A	N/A	Flare Traversable RT?	N/A
N/A	Landing Length (in)	N/A	N/A	DWS Provided?	N/A
N/A	Landing Width (in)	N/A	N/A	DWS Contrast?	N/A
N/A	Landing Slope (%)	N/A	N/A	DWS Length (in)	N/A
N/A	Landing X Slope (%)	N/A	N/A	DWS Full Width?	N/A
N/A	Landing Curb? (Y/N)	N/A	N/A	DWS Offset (in)	N/A
N/A	Shared Landing?	N/A			
N/A	Gutter Ponding?	N/A	N/A	Gutter Slope (%)	N/A
N/A	Gutter Lip Ht (in)	N/A	N/A	Gutter X Slope (%)	N/A
N/A	Painted X Walk1?	No	N/A	Painted X Walk2?	No
	X Walk 1 Direction	To SE		X Walk 2 Direction	To NE
N/A	X Walk 1 Width (in)	N/A	N/A	X Walk 2 Width (in)	N/A
	X Walk 1 Slope (%)	3.9		X Walk 2 Slope (%)	1.5
	X Walk 1 X Slope (%)	1.8		X Walk 2 X Slope (%)	1.0

N/A	Ramp inside XWalk1?	N/A	N/A	Ramp inside XWalk2?	N/A
	Road Slope (%)	0.6	N/A	Clear Space?	N/A
	Road X Slope (%)	0.7	N/A	Clear Space to XWalk (in)	N/A
N/A	Any Obstructions?	N/A	N/A	Storm Grate/Utility Hazard?	N/A
	Obstruction Type			Storm Grate/Utility Type	
		N/A			N/A
			Yes	Surface Condition? (G/P)	Good

**Remove & Replace Curb Ramp With Two New Directional Ramps or Equivalent.**
