# Access Compliance Report

## Public Rights-of-Way

### (Curb Ramps)

| Intersection ID: 51704 | Main Street: IKEA_BV | Cross Street: BROOKSIDE_LN | Location: NW |

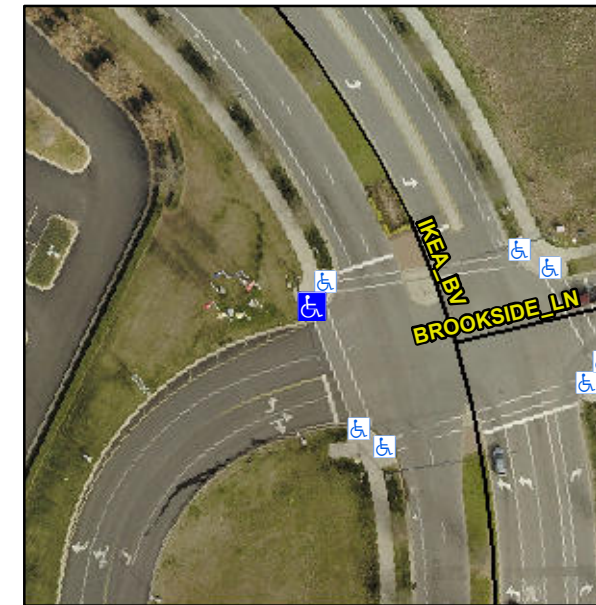
**Not Found, R304.5.3, R304.2.2-Perp,  
R304.3.2-Para, R302.7.2**

| Compliance | Description | Data | Compliance | Description | Data |
|---|---|---|---|---|---|
| Yes | Ramp Width (in) | 48.0 | No | Ramp XSlope (%) | 2.5 |
| No | Landing Slope (%) | 2.7 | Yes | DWS Length (in) | 24.5 |
| No | Gutter Lip Ht (in) | 0.5 | No | Gutter X Slope (%) | 3.2 |

**Remove & Replace Entire Ramp.  
Remove & Replace Gutter.**
