Access Compliance Report

Public Rights-of-Way

(Curb Ramps)

Intersection ID: N/A	Main Street: BROOKSVALE_ST	Cross Street: NOBLES_AV	Location: S
ADA ID: 9F10A4B4CBCD	Ramp Type: Perp	Initial Pass/Fail: Fail	Overall Compliance: No
Codes/Mitigation Info/Possible Solution		Field Measurements/Component Compliance	
Severity Score: 25

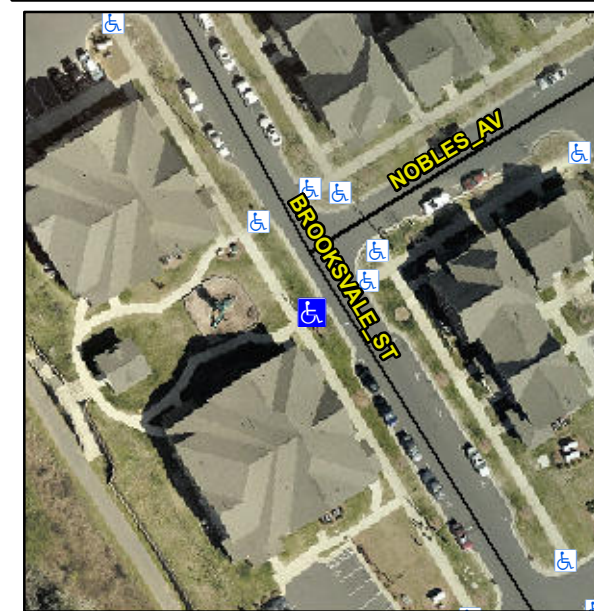
Compliance	Description	Data	Compliance	Description	Data
N/A	Ramp Length (in)	73.0	Yes	Ramp Slope (%)	5.5
Yes	Ramp Width (in)	70.0	No	Ramp XSlope (%)	7.6
N/A	Flare Type LT	N/A	N/A	Flare Type RT	N/A
N/A	Flare Slope LT (%)	N/A	N/A	Flare Slope RT (%)	N/A
N/A	Flare Traversable LT?	N/A	N/A	Flare Traversable RT?	N/A
N/A	Landing Length (in)	N/A	N/A	DWS Provided?	N/A
N/A	Landing Width (in)	N/A	N/A	DWS Contrast?	N/A
N/A	Landing Slope (%)	N/A	N/A	DWS Length (in)	N/A
N/A	Landing X Slope (%)	N/A	N/A	DWS Full Width?	N/A
N/A	Landing Curb? (Y/N)	N/A	N/A	DWS Offset (in)	N/A
N/A	Shared Landing?	N/A			
N/A	Gutter Ponding?	N/A	N/A	Gutter Slope (%)	N/A
N/A	Gutter Lip Ht (in)	N/A	N/A	Gutter X Slope (%)	N/A
N/A	Painted X Walk1?	No	N/A	Painted X Walk2?	N/A
	X Walk 1 Direction	To E		X Walk 2 Direction	N/A
N/A	X Walk 1 Width (in)	N/A	N/A	X Walk 2 Width (in)	N/A
	X Walk 1 Slope (%)	2.6		X Walk 2 Slope (%)	N/A
	X Walk 1 X Slope (%)	1.1		X Walk 2 X Slope (%)	N/A

N/A	Ramp inside XWalk1?	N/A	N/A	Ramp inside XWalk2?	N/A
	Road Slope (%)	N/A	N/A	Clear Space?	N/A
	Road X Slope (%)	N/A	N/A	Clear Space to XWalk (in)	N/A
N/A	Any Obstructions?	N/A	N/A	Storm Grate/Utility Hazard?	N/A
	Obstruction Type			Storm Grate/Utility Type	
		N/A			N/A
		Yes		Surface Condition? (G/P)	Good

Possible Solutions:

Remove & Replace Entire Ramp.
