Access Compliance Report

Public Rights-of-Way

(Curb Ramps)

Intersection ID: 5090	Main Street: EDMONTON_PL	Cross Street: SARNIA_PL	Location: NW
ADA ID: 9F2C592D866E	Ramp Type: Perp	Initial Pass/Fail: Fail	Overall Compliance: No
Severity Score: 13.75			
Codes/Mitigation Info/Possible Solution		Field Measurements/Component Compliance

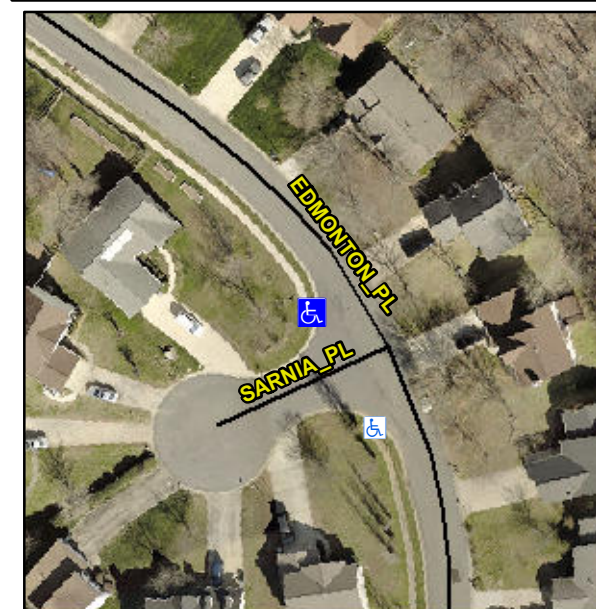
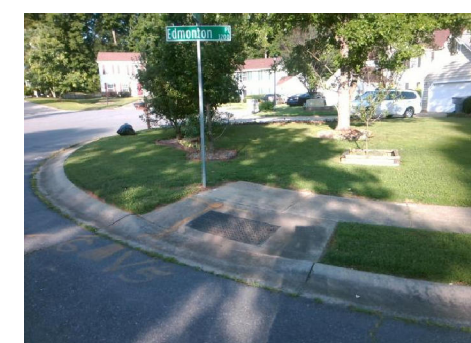
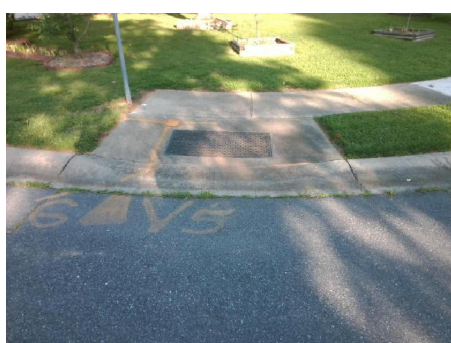
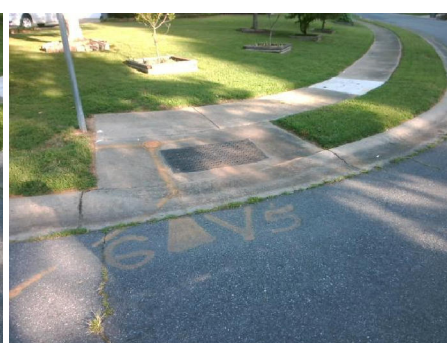
Compliance	Description	Data	Compliance	Description	Data
N/A	Ramp Length (in)	47.0	No	Ramp Slope (%)	11.3
Yes	Ramp Width (in)	48.0	No	Ramp XSlope (%)	4.7
N/A	Flare Type LT	N/A	N/A	Flare Type RT	N/A
N/A	Flare Slope LT (%)	N/A	N/A	Flare Slope RT (%)	N/A
N/A	Flare Traversable LT?	N/A	N/A	Flare Traversable RT?	N/A
N/A	Landing Length (in)	N/A	N/A	DWS Provided?	N/A
N/A	Landing Width (in)	N/A	N/A	DWS Contrast?	N/A
N/A	Landing Slope (%)	N/A	N/A	DWS Length (in)	N/A
N/A	Landing X Slope (%)	N/A	N/A	DWS Full Width?	N/A
N/A	Landing Curb? (Y/N)	N/A	N/A	DWS Offset (in)	N/A
N/A	Shared Landing?	N/A			
N/A	Gutter Ponding?	N/A	N/A	Gutter Slope (%)	N/A
N/A	Gutter Lip Ht (in)	N/A	N/A	Gutter X Slope (%)	N/A
N/A	Painted X Walk1?	No	N/A	Painted X Walk2?	N/A
	X Walk 1 Direction	To S		X Walk 2 Direction	N/A
N/A	X Walk 1 Width (in)	N/A	N/A	X Walk 2 Width (in)	N/A
	X Walk 1 Slope (%)	5.6		X Walk 2 Slope (%)	N/A
	X Walk 1 X Slope (%)	1.8		X Walk 2 X Slope (%)	N/A

N/A	Ramp inside XWalk1?	N/A	N/A	Ramp inside XWalk2?	N/A
	Road Slope (%)	N/A	N/A	Clear Space?	N/A
	Road X Slope (%)	N/A	N/A	Clear Space to XWalk (in)	N/A
N/A	Any Obstructions?	N/A	N/A	Storm Grate/Utility Hazard?	N/A
	Obstruction Type			Storm Grate/Utility Type	
		N/A			N/A
		Yes		Surface Condition? (G/P)	Good

Possible Solutions:

Remove & Replace Entire Ramp.

R304.2.2, R304.5.3
