## Access Compliance Report Public Rights-of-Way (Curb Ramps)

Intersection ID: 3549Main Street:SHELTER\_COVE\_LNCross Street:TRANQUILLITY\_DRLocation:SWADA ID: 9F3155948F11Ramp Type:PerpInitial Pass/Fail:FailOverall Compliance:NoSeverity Score:13.75

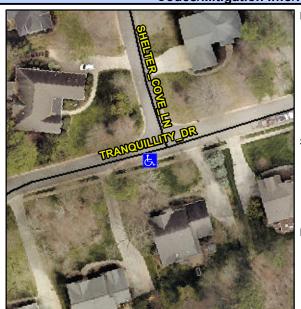
Field Measurements/Component Compliance								
Compl	iance Description	Data	Compl	iance	Description	Data		
N/A	Ramp Length (in)	47.0	No	Ramp	Slope (%)	8.9		
Yes	Ramp Width (in)	49.0	Yes	Ramp	XSlope (%)	4.5		
N/A	Flare Type LT	N/A	N/A	Flare	Type RT	N/A		
N/A	Flare Slope LT (%)	N/A	N/A	Flare	Slope RT (%)	N/A		
N/A	Flare Traversable LT?	N/A	N/A	Flare	Traversable RT?	N/A		
N/A	Landing Length (in)	N/A	N/A	DWS	Provided?	N/A		
N/A	Landing Width (in)	N/A	N/A	DWS	Contrast?	N/A		
N/A	Landing Slope (%)	N/A	N/A	DWS	Length (in)	N/A		
N/A	Landing X Slope (%)	N/A	N/A	DWS	Full Width?	N/A		
N/A	Landing Curb? (Y/N)	N/A	N/A	DWS	Offset (in)	N/A		
N/A	Shared Landing?	N/A						
N/A	Gutter Ponding?	N/A	N/A	Gutte	r Slope (%)	N/A		
N/A	Gutter Lip Ht (in)	N/A	N/A	Gutte	r X Slope (%)	N/A		
N/A	Painted X Walk1?	No	N/A	Painte	ed X Walk2?	N/A		
	X Walk 1 Direction	To N		X Wa	k 2 Direction	N/A		
N/A	X Walk 1 Width (in)	N/A	N/A	X Wa	k 2 Width (in)	N/A

X Walk 1 Slope (%)	2.3		X Wa	k 2 Slope (%)	N/A		
	X Walk 1 X Slope (%)	4.5		X Wa	k 2 X Slope (%)	N/A		
N/A	Ramp inside XWalk1?	N/A	N/A	Ramp	inside XWalk2?	N/A		
	Road Slope (%)	4.5	N/A	Clear	Space?	N/A		
	Road X Slope (%)	2.3	N/A	Clear	Space to XWalk (in)	N/A		
N/A	Any Obstructions?	N/A	N/A	Storm	Grate/Utility Hazard?	N/A		
	Obstruction Type			Storm	Grate/Utility Type			
		N/A				N/A		
			Yes	Surfa	ce Condition? (G/P)	Good

Possible Solutions:	<u>c</u>		
Remove & Replace Entire Ramp.			
	Y		
	N		
	N		
	N		
	N		
Surveyor Notes:	N		
N/A	N		
	N		
	N		
	N		
PROW/ADA:	N		
Not Found, R304.2.2	N		
	N		
	N		
	N
