Access Compliance Report

Public Rights-of-Way

(Curb Ramps)

Intersection ID: 48450	Main Street: DUSTY_SADDLE_RD	Cross Street: RED_RUST_LN	Location: SW
ADA ID: 9F36AAD98F24	Ramp Type: Perp	Initial Pass/Fail: Fail	Overall Compliance: No
Severity Score: 8.75			
Codes/Mitigation Info/Possible Solution		Field Measurements/Component Compliance

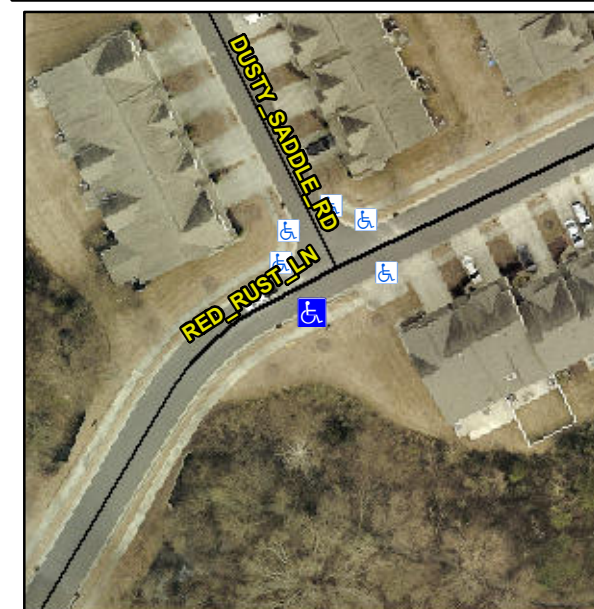
Compliance	Description	Data	Compliance	Description	Data
N/A	Ramp Length (in)	107.0	Yes	Ramp Slope (%)	7.3
No	Ramp Width (in)	47.0	Yes	Ramp XSlope (%)	1.5
N/A	Flare Type LT	N/A	N/A	Flare Type RT	N/A
N/A	Flare Slope LT (%)	N/A	N/A	Flare Slope RT (%)	N/A
N/A	Flare Traversable LT?	N/A	N/A	Flare Traversable RT?	N/A
N/A	Landing Length (in)	N/A	N/A	DWS Provided?	N/A
N/A	Landing Width (in)	N/A	N/A	DWS Contrast?	N/A
N/A	Landing Slope (%)	N/A	N/A	DWS Length (in)	N/A
N/A	Landing X Slope (%)	N/A	N/A	DWS Full Width?	N/A
N/A	Landing Curb? (Y/N)	N/A	N/A	DWS Offset (in)	N/A
N/A	Shared Landing?	N/A			
N/A	Gutter Ponding?	N/A	N/A	Gutter Slope (%)	N/A
N/A	Gutter Lip Ht (in)	N/A	N/A	Gutter X Slope (%)	N/A
N/A	Painted X Walk1?	No	N/A	Painted X Walk2?	N/A
	X Walk 1 Direction	To NW		X Walk 2 Direction	N/A
N/A	X Walk 1 Width (in)	N/A	N/A	X Walk 2 Width (in)	N/A
	X Walk 1 Slope (%)	0.5		X Walk 2 Slope (%)	N/A
	X Walk 1 X Slope (%)	1.9		X Walk 2 X Slope (%)	N/A

Remove & Replace Entire Ramp.

R304.5.1
