# Access Compliance Report

## Public Rights-of-Way

### (Curb Ramps)

Intersection ID: 43145	Main Street: E_INDEPENDENCE_BV	Cross Street: E_INDEPENDENCE/BRIAR_CREEK_RA	Location: SW
ADA ID: 9F3965908E62	Ramp Type: Perp	Initial Pass/Fail: Fail	Overall Compliance: No
Severity Score: 8.75			
Codes/Mitigation Info/Possible Solution		Field Measurements/Component Compliance

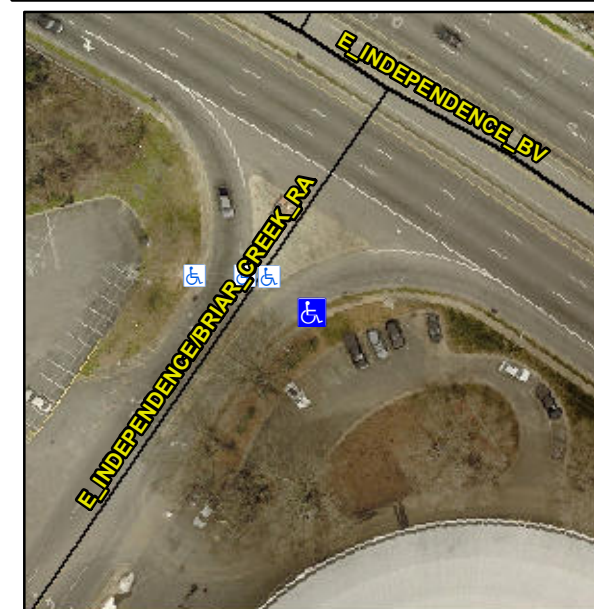
**Not Found, R304.5.1**

Compliance	Description	Data	Compliance	Description	Data
N/A	Ramp Length (in)	30.0	Yes	Ramp Slope (%)	7.7
No	Ramp Width (in)	41.0	Yes	Ramp XSlope (%)	0.5
N/A	Flare Type LT	N/A	N/A	Flare Type RT	N/A
N/A	Flare Slope LT (%)	N/A	N/A	Flare Slope RT (%)	N/A
N/A	Flare Traversable LT?	N/A	N/A	Flare Traversable RT?	N/A
N/A	Landing Length (in)	N/A	N/A	DWS Provided?	N/A
N/A	Landing Width (in)	N/A	N/A	DWS Contrast?	N/A
N/A	Landing Slope (%)	N/A	N/A	DWS Length (in)	N/A
N/A	Landing X Slope (%)	N/A	N/A	DWS Full Width?	N/A
N/A	Landing Curb? (Y/N)	N/A	N/A	DWS Offset (in)	N/A
N/A	Shared Landing?	N/A			
N/A	Gutter Ponding?	N/A	N/A	Gutter Slope (%)	N/A
N/A	Gutter Lip Ht (in)	N/A	N/A	Gutter X Slope (%)	N/A
N/A	Painted X Walk1?	No	N/A	Painted X Walk2?	N/A
	X Walk 1 Direction	To N		X Walk 2 Direction	N/A
N/A	X Walk 1 Width (in)	N/A	N/A	X Walk 2 Width (in)	N/A
	X Walk 1 Slope (%)	0.8		X Walk 2 Slope (%)	N/A
	X Walk 1 X Slope (%)	0.1		X Walk 2 X Slope (%)	N/A

N/A	Ramp inside XWalk1?	N/A	N/A	Ramp inside XWalk2?	N/A
	Road Slope (%)	N/A	N/A	Clear Space?	N/A
	Road X Slope (%)	N/A	N/A	Clear Space to XWalk (in)	N/A
N/A	Any Obstructions?	N/A	N/A	Storm Grate/Utility Hazard?	N/A
	Obstruction Type			Storm Grate/Utility Type	
		N/A			N/A
			Yes	Surface Condition? (G/P)	Good

**Remove & Replace Entire Ramp.**

Total Cost: \$ 1850.00
