# Access Compliance Report

## Public Rights-of-Way

### (Curb Ramps)

| Intersection ID: 13736 | Main Street: CAMDEN_RD | Cross Street: E_PARK_AV | Location: | S |

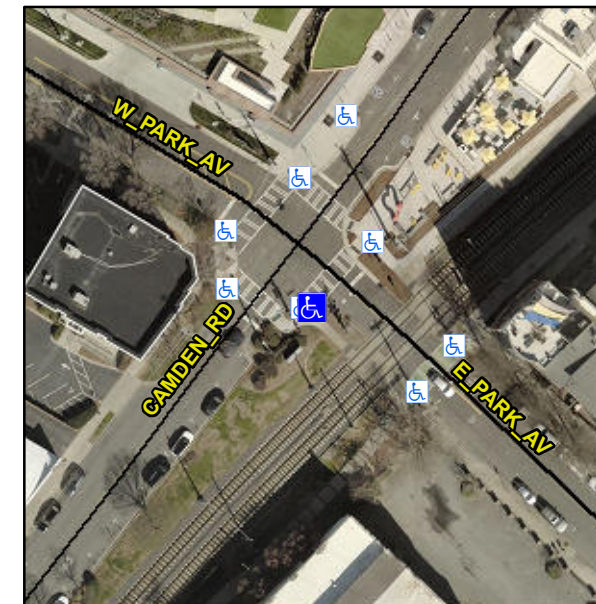
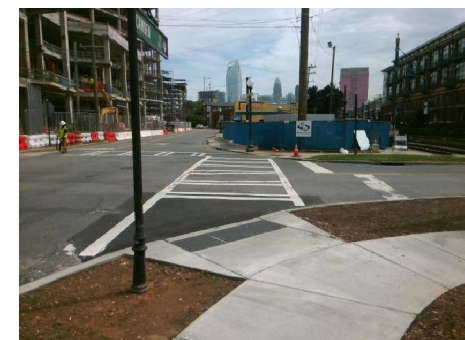
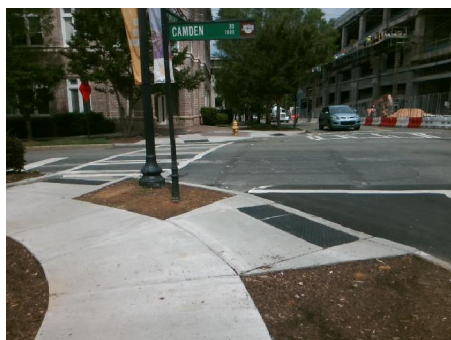
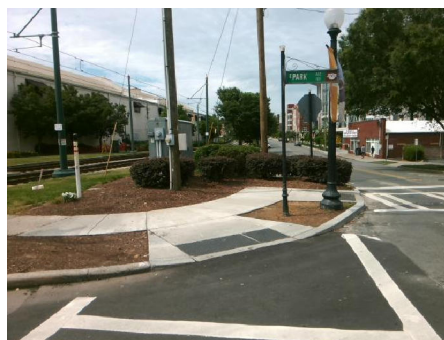
| ADA ID: 9F4D8444676F | Ramp Type: BlendTrans1 | Initial Pass/Fail: Pass | Overall Compliance: No | Severity Score: 0 |

**R304.5.3**

| Compliance | Description | Data | Compliance | Description | Data |
|---|---|---|---|---|---|
| Yes | Gutter Lip Ht (in) | 0.0 | No | Gutter X Slope (%) | 2.2 |

**Remove & Replace Gutter.**

\$ 750.00
