Access Compliance Report

Public Rights-of-Way

(Curb Ramps)

Intersection ID: 50582	Main Street: DOWNY_BIRCH_RD	Cross Street: PAPER_TREE_RD	Location: NW
ADA ID: 9F4F58CB2925	Ramp Type: Perp	Initial Pass/Fail: Fail	Overall Compliance: No
Severity Score: 8.75			
Codes/Mitigation Info/Possible Solution		Field Measurements/Component Compliance

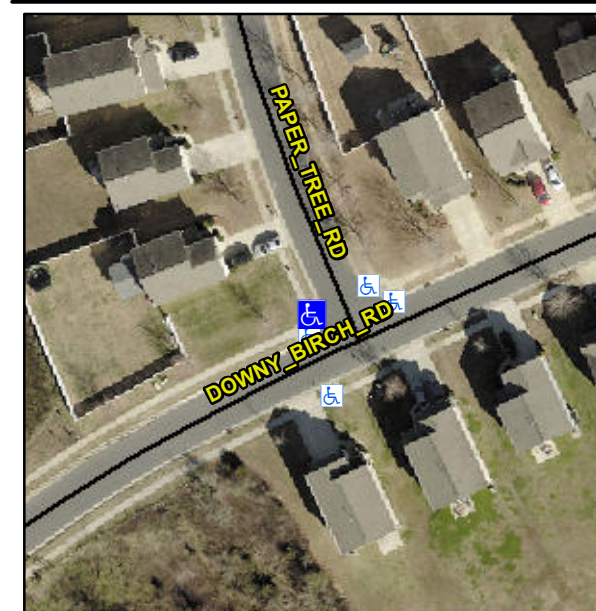
Not Found, R304.5.1

Compliance	Description	Data	Compliance	Description	Data
N/A	Ramp Length (in)	48.5	Yes	Ramp Slope (%)	6.1
No	Ramp Width (in)	47.5	Yes	Ramp XSlope (%)	0.1
N/A	Flare Type LT	N/A	N/A	Flare Type RT	N/A
N/A	Flare Slope LT (%)	N/A	N/A	Flare Slope RT (%)	N/A
N/A	Flare Traversable LT?	N/A	N/A	Flare Traversable RT?	N/A
N/A	Landing Length (in)	N/A	N/A	DWS Provided?	N/A
N/A	Landing Width (in)	N/A	N/A	DWS Contrast?	N/A
N/A	Landing Slope (%)	N/A	N/A	DWS Length (in)	N/A
N/A	Landing X Slope (%)	N/A	N/A	DWS Full Width?	N/A
N/A	Landing Curb? (Y/N)	N/A	N/A	DWS Offset (in)	N/A
N/A	Shared Landing?	N/A			
N/A	Gutter Ponding?	N/A	N/A	Gutter Slope (%)	N/A
N/A	Gutter Lip Ht (in)	N/A	N/A	Gutter X Slope (%)	N/A
N/A	Painted X Walk1?	No	N/A	Painted X Walk2?	N/A
	X Walk 1 Direction	To E		X Walk 2 Direction	N/A
N/A	X Walk 1 Width (in)	N/A	N/A	X Walk 2 Width (in)	N/A
	X Walk 1 Slope (%)	3.1		X Walk 2 Slope (%)	N/A
	X Walk 1 X Slope (%)	2.2		X Walk 2 X Slope (%)	N/A

N/A	Ramp inside XWalk1?	N/A	N/A	Ramp inside XWalk2?	N/A
	Road Slope (%)	N/A	N/A	Clear Space?	N/A
	Road X Slope (%)	N/A	N/A	Clear Space to XWalk (in)	N/A
N/A	Any Obstructions?	N/A	N/A	Storm Grate/Utility Hazard?	N/A
	Obstruction Type			Storm Grate/Utility Type	
		N/A			N/A
		Yes		Surface Condition? (G/P)	Good

Remove & Replace Entire Ramp.
