Access Compliance Report

Public Rights-of-Way

(Curb Ramps)

Intersection ID: 28763	Main Street: CAMBRIDGE COMMONS DR	Cross Street: GREATFORD CT	Location: NW
ADA ID: 9F5116FFDD4D	Ramp Type: BlendTrans1	Initial Pass/Fail: Fail	Overall Compliance: No
		Severity Score: 10

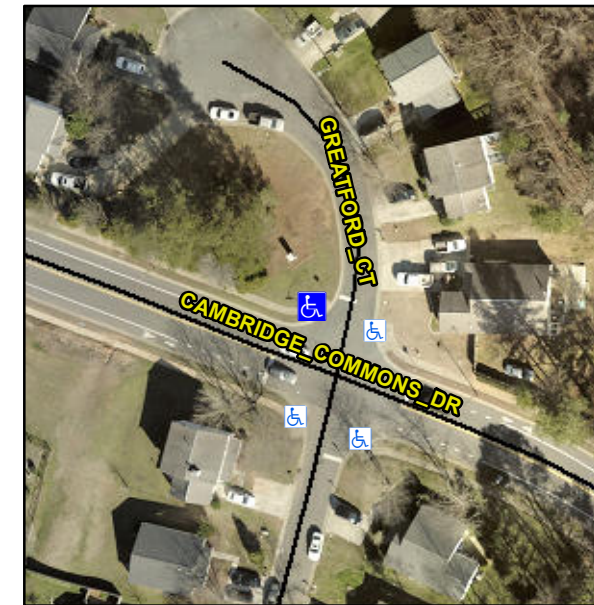
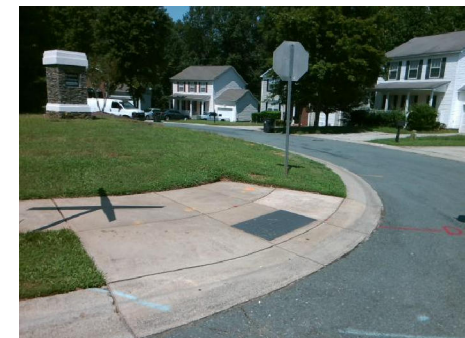
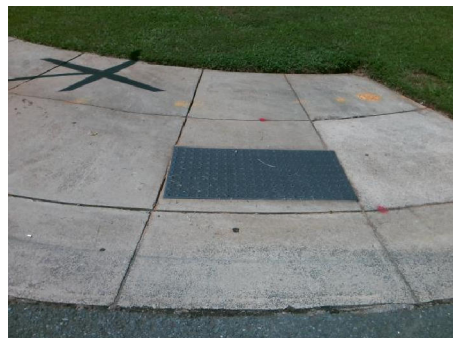
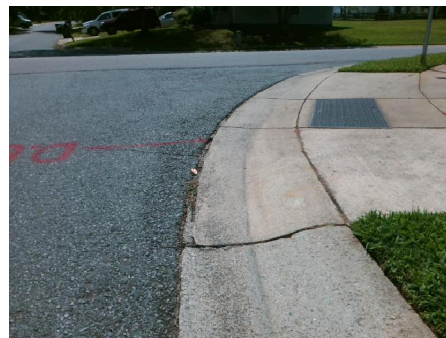
NO RT SW

Compliance	Description	Data	Compliance	Description	Data
N/A	Ramp Length (in)	49.0	Yes	BlendTrans Slope (%)	3.4
No	Ramp Width (in)	43.0	No	BlendTrans XSlope (%)	4.1
N/A	Flare Type LT	N/A	N/A	Flare Type RT	N/A
N/A	Flare Slope LT (%)	N/A	N/A	Flare Slope RT (%)	N/A
N/A	Flare Traversable LT?	N/A	N/A	Flare Traversable RT?	N/A
N/A	Landing Length (in)	N/A	N/A	DWS Provided?	N/A
N/A	Landing Width (in)	N/A	N/A	DWS Contrast?	N/A
N/A	Landing Slope (%)	N/A	N/A	DWS Length (in)	N/A
N/A	Landing X Slope (%)	N/A	N/A	DWS Full Width?	N/A
N/A	Landing Curb? (Y/N)	N/A	N/A	DWS Offset (in)	N/A
N/A	Shared Landing?	N/A			
N/A	Gutter Ponding?	N/A	N/A	Gutter Slope (%)	N/A
N/A	Gutter Lip Ht (in)	N/A	N/A	Gutter X Slope (%)	N/A
N/A	Painted X Walk1?	No	N/A	Painted X Walk2?	No
	X Walk 1 Direction	To S		X Walk 2 Direction	To E
	X Walk 1 Width (in)	N/A		X Walk 2 Width (in)	N/A
	X Walk 1 Slope (%)	2.4		X Walk 2 Slope (%)	0.7
	X Walk 1 X Slope (%)	0.6		X Walk 2 X Slope (%)	4.6

N/A	Ramp inside XWalk1?	N/A	N/A	Ramp inside XWalk2?	N/A
	Road Slope (%)	4.7		Clear Space?	N/A
	Road X Slope (%)	3.8	N/A	Clear Space to XWalk (in)	N/A
N/A	Any Obstructions?	N/A	N/A	Storm Grate/Utility Hazard?	N/A
	Obstruction Type			Storm Grate/Utility Type	
		N/A			N/A
			Yes	Surface Condition? (G/P)	Good
			N/A	Curb Slope (%)	N/A

Remove & Replace Curb Ramp With Two New Directional Ramps or Equivalent.

R304.5.1, R304.5.3
