Access Compliance Report

Public Rights-of-Way

(Curb Ramps)

Intersection ID: 15806	Main Street: EAST_BV	Cross Street: MARYLAND_AV	Location: SW
ADA ID: 9F58AD90DE07	Ramp Type: Directional1	Initial Pass/Fail: Fail	Overall Compliance: No
			Severity Score: 26.25

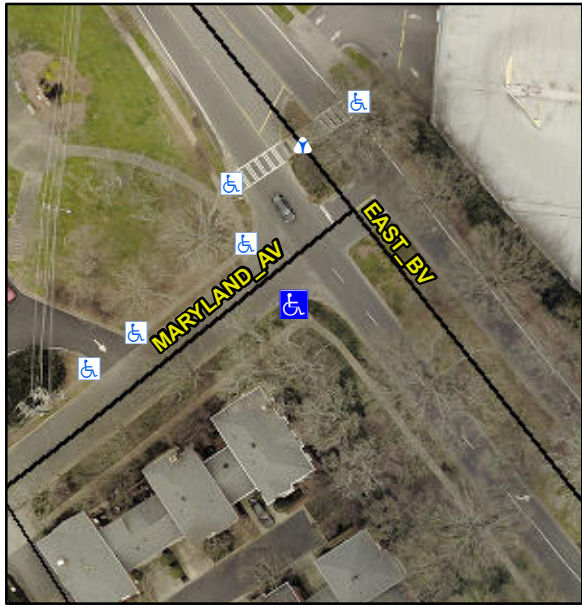
Possible Solutions:		Compliance	Description	Data	Compliance	Description	Data
	Remove & Replace Entire Ramp.		N/A	Ramp Length (in)	85.0	N/A	Grade Break?	N/A
			Yes	Ramp Width (in)	69.0	N/A	Grade Break Slope (%)	0.0
			No	Ramp Slope (%)	16.3	N/A	Grade Break XSlope (%)	0.0
			No	Ramp XSlope (%)	3.7			
			N/A	Flare Type LT	N/A	N/A	Flare Type RT	N/A
			N/A	Flare Slope LT (%)	N/A	N/A	Flare Slope RT (%)	0.0
			N/A	Flare Traversable LT?	N/A	N/A	Flare Traversable RT?	N/A
	Surveyor Notes:		N/A	Landing Length (in)	0.0	N/A	DWS Provided?	N/A
	PONDING		N/A	Landing Width (in)	0.0	N/A	DWS Contrast?	N/A
			N/A	Landing Slope (%)	0.0	N/A	DWS Length (in)	N/A
			N/A	Landing X Slope (%)	0.0	N/A	DWS Full Width?	N/A
PROW/ADA:			N/A	Landing Curb? (Y/N)	N/A	N/A	DWS Offset LT (in)	N/A
R304.2.2, R304.5.3			N/A	Shared Landing?	N/A	N/A	DWS Offset RT (in)	N/A
