Access Compliance Report

Public Rights-of-Way

(Curb Ramps)

Intersection ID: 49101	Main Street: PROSPERITY_CROSSING_DR	Cross Street: DOCIA_CROSSING_RD	Location: SE
ADA ID: 9F59CA7A8B11	Ramp Type: Perp	Initial Pass/Fail: Fail	Overall Compliance: No
Severity Score: 25			
Codes/Mitigation Info/Possible Solution		Field Measurements/Component Compliance

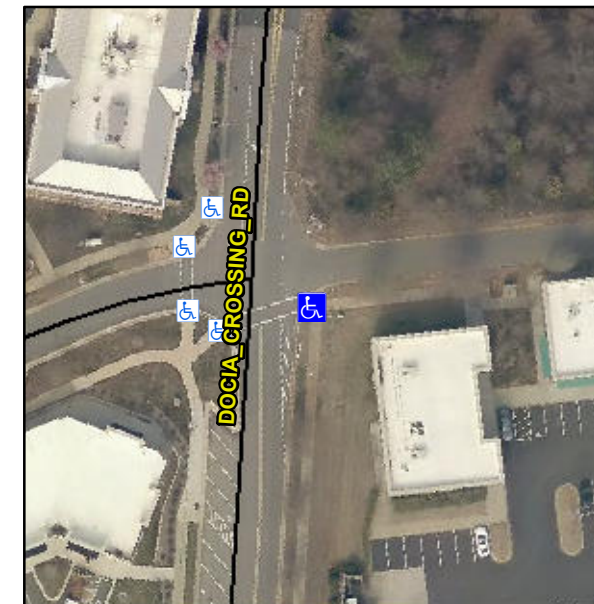
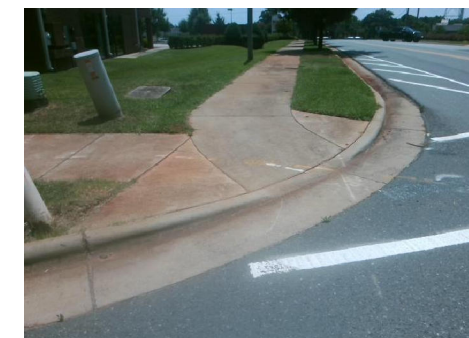
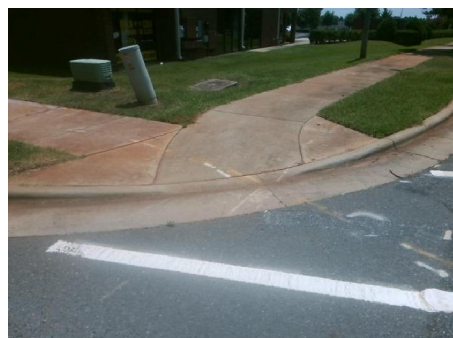
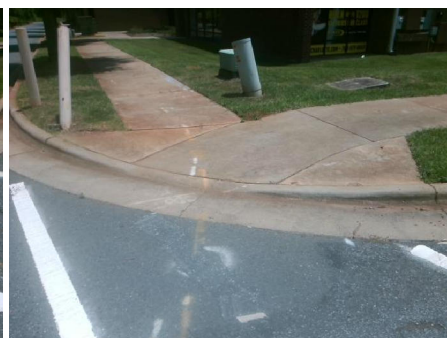
Compliance	Description	Data	Compliance	Description	Data
N/A	Ramp Length (in)	73.0	No	Ramp Slope (%)	13.1
Yes	Ramp Width (in)	48.0	Yes	Ramp XSlope (%)	0.7
N/A	Flare Type LT	N/A	N/A	Flare Type RT	N/A
N/A	Flare Slope LT (%)	N/A	N/A	Flare Slope RT (%)	N/A
N/A	Flare Traversable LT?	N/A	N/A	Flare Traversable RT?	N/A
N/A	Landing Length (in)	N/A	N/A	DWS Provided?	N/A
N/A	Landing Width (in)	N/A	N/A	DWS Contrast?	N/A
N/A	Landing Slope (%)	N/A	N/A	DWS Length (in)	N/A
N/A	Landing X Slope (%)	N/A	N/A	DWS Full Width?	N/A
N/A	Landing Curb? (Y/N)	N/A	N/A	DWS Offset (in)	N/A
N/A	Shared Landing?	N/A			
N/A	Gutter Ponding?	N/A	N/A	Gutter Slope (%)	N/A
N/A	Gutter Lip Ht (in)	N/A	N/A	Gutter X Slope (%)	N/A
N/A	Painted X Walk1?	Yes	N/A	Painted X Walk2?	N/A
	X Walk 1 Direction	To W		X Walk 2 Direction	N/A
N/A	X Walk 1 Width (in)	83.0	N/A	X Walk 2 Width (in)	N/A
	X Walk 1 Slope (%)	1.3		X Walk 2 Slope (%)	N/A
	X Walk 1 X Slope (%)	0.2		X Walk 2 X Slope (%)	N/A

N/A	Ramp inside XWalk1?	Yes	N/A	Ramp inside XWalk2?	N/A
	Road Slope (%)	N/A	N/A	Clear Space?	N/A
	Road X Slope (%)	N/A	N/A	Clear Space to XWalk (in)	N/A
N/A	Any Obstructions?	N/A	N/A	Storm Grate/Utility Hazard?	N/A
	Obstruction Type			Storm Grate/Utility Type	
		N/A			N/A
			Yes	Surface Condition? (G/P)	Good

Possible Solutions:

Remove & Replace Entire Ramp.
