Access Compliance Report

Public Rights-of-Way

(Curb Ramps)

Intersection ID: 14202	Main Street: E_3RD_ST	Cross Street: LILLINGTON AV	Location: SW
ADA ID: 9F5B39101245	Ramp Type: PerpDiag	Initial Pass/Fail: Fail	Overall Compliance: No
		Severity Score: 8.75

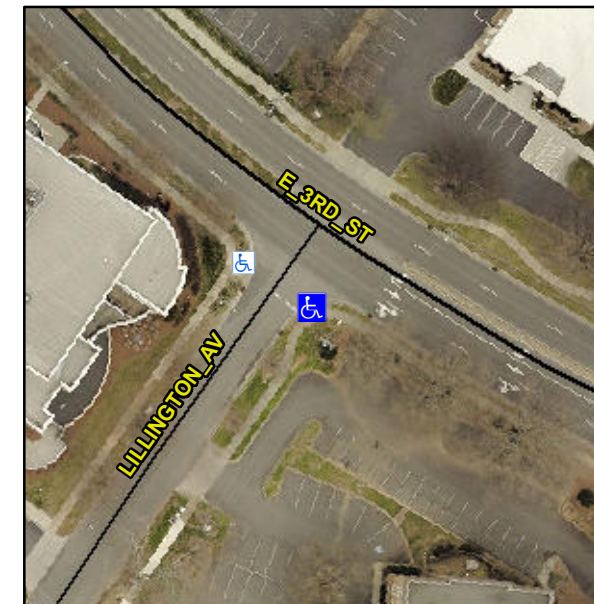
Compliance	Description	Data	Compliance	Description	Data
N/A	Ramp Length (in)	83.5	Yes	Ramp Slope (%)	6.4
No	Ramp Width (in)	36.0	Yes	Ramp XSlope (%)	0.3
N/A	Flare Type LT	N/A	N/A	Flare Type RT	N/A
N/A	Flare Slope LT (%)	N/A	N/A	Flare Slope RT (%)	N/A
N/A	Flare Traversable LT?	N/A	N/A	Flare Traversable RT?	N/A
N/A	Landing Length (in)	N/A	N/A	DWS Provided?	N/A
N/A	Landing Width (in)	N/A	N/A	DWS Contrast?	N/A
N/A	Landing Slope (%)	N/A	N/A	DWS Length (in)	N/A
N/A	Landing X Slope (%)	N/A	N/A	DWS Full Width?	N/A
N/A	Landing Curb? (Y/N)	N/A	N/A	DWS Offset (in)	N/A
N/A	Shared Landing?	N/A			
N/A	Gutter Ponding?	N/A	N/A	Gutter Slope (%)	N/A
N/A	Gutter Lip Ht (in)	1.0	N/A	Gutter X Slope (%)	N/A
N/A	Painted X Walk1?	No	N/A	Painted X Walk2?	No
	X Walk 1 Direction	To NE		X Walk 2 Direction	To NW
N/A	X Walk 1 Width (in)	N/A	N/A	X Walk 2 Width (in)	N/A
	X Walk 1 Slope (%)	1.7		X Walk 2 Slope (%)	0.6
	X Walk 1 X Slope (%)	0.8		X Walk 2 X Slope (%)	1.2

N/A	Ramp inside XWalk1?	N/A	N/A	Ramp inside XWalk2?	N/A
	Road Slope (%)	0.3	N/A	Clear Space?	N/A
	Road X Slope (%)	0.3	N/A	Clear Space to XWalk (in)	N/A
N/A	Any Obstructions?	N/A	N/A	Storm Grate/Utility Hazard?	N/A
	Obstruction Type			Storm Grate/Utility Type	
		N/A			N/A
			Yes	Surface Condition? (G/P)	Good

Remove & Replace Curb Ramp With Two New Directional Ramps or Equivalent.
