Access Compliance Report Public Rights-of-Way (Curb Ramps)

· · · ·										
Intersection ID: 18579	Main Str	Cross Street: WATERLEAF_LN					Location:	NE		
ADA ID: 9F6454B2F0DA	Ramp Ty	Initial Pass/Fail: Fail Overall Compliance:				ce: N	o Severity Score:	12.5		
Codes/Mitigation Info/Possible Solution				Field Measurements/Component Compliance						
		Possible Solutions:	Compliance Description			Data	Data Compliance Description			
		Remove & Replace Curb Ramp W	ith N	I/A	Ramp Length (in)	38.0	No	Ramp Slope (%)	9.4	
		Two New Directional Ramps or		'es	Ramp Width (in)	48.0	Yes	Ramp XSlope (%)	0.4	
		Equivalent.	Ν	I/A	Flare Type LT	N/A	N/A	Flare Type RT	N/A	
			N	I/A	Flare Slope LT (%)	N/A	N/A	Flare Slope RT (%)	N/A	
			N	I/A	Flare Traversable LT?	N/A	N/A	Flare Traversable RT?	N/A	
			N	I/A	Landing Length (in)	N/A	N/A	DWS Provided?	N/A	
		Surveyor Notes:	N	I/A	Landing Width (in)	N/A	N/A	DWS Contrast?	N/A	
		N/A	N	I/A	Landing Slope (%)	N/A	N/A	DWS Length (in)	N/A

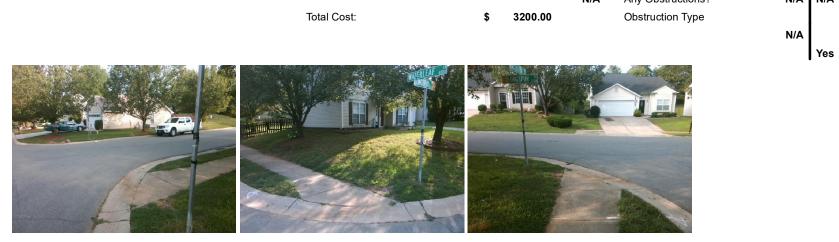
LONGSPUR I			N	I/A	Landing X Slope (%)	N/A	N/A	DWS Full Width?	N/A	
the state of the s			N	I/A	Landing Curb? (Y/N)	N/A	N/A	DWS Offset (in)	N/A	
	stall a comment		N	I/A	Shared Landing?	N/A

W. LAN	PROW/ADA:	N	I/A	Gutter Ponding?	N/A	N/A	Gutter Slope (%)	N/A	
	1 2	R304.2.2	Ν	I/A	Gutter Lip Ht (in)	N/A	N/A	Gutter X Slope (%)	N/A	
	A 15		N	I/A	Painted X Walk1?	No	N/A	Painted X Walk2?	No	
	And Top of the				X Walk 1 Direction	To NW		X Walk 2 Direction	To SW	
and the second s			N	I/A	X Walk 1 Width (in)	N/A	N/A	X Walk 2 Width (in)	N/A	
Street 1 Name	WATERLEAF LN				X Walk 1 Slope (%)	0.3		X Walk 2 Slope (%)	0.9	
Stop Condition-Street 2	StopSign				X Walk 1 X Slope (%)	1.2		X Walk 2 X Slope (%)	0.7	
Street 2 Name	LONGSPUR DR		N	I/A	Ramp inside XWalk1?	N/A	N/A	Ramp inside XWalk2?	N/A	
Stop Condition-Street 1	None				Road Slope (%)	0.0	N/A	Clear Space?	N/A	
					Road X Slope (%)	2.2	N/A	Clear Space to XWalk (in)	N/A	
			١	A/A	Any Obstructions?	N/A	N/A	Storm Grate/Utility Hazard?	N/A	
		Total Cost: \$ 32	200.00		Obstruction Type			Storm Grate/Utility Type		
						N/A			N/A
