Access Compliance Report Public Rights-of-Way (Curb Ramps)

Intersection ID: 44420 Main Street: PROVIDENCE_PROMENADE_D@rd%s Street: PROVIDENCE_PROMENADE_DR_S Location: ADA ID: 9F67CD905D99 Ramp Type: Perp Initial Pass/Fail: Fail **Overall Compliance: No** Severity Score: 21.25

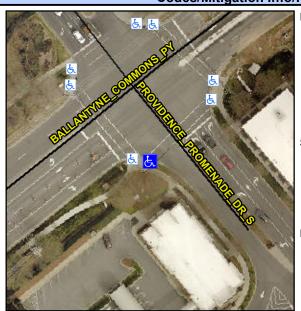
Field Measurements/Component Compliance							
Comp	liance Description	Data	Comp	liance Description	Data		
N/A	Ramp Length (in)	73.0	Yes	Ramp Slope (%)	5.3		
No	Ramp Width (in)	44.5	No	Ramp XSlope (%)	5.3		
N/A	Flare Type LT	N/A	N/A	Flare Type RT	N/A		
N/A	Flare Slope LT (%)	N/A	N/A	Flare Slope RT (%)	N/A		
N/A	Flare Traversable LT?	N/A	N/A	Flare Traversable RT?	N/A		
N/A	Landing Length (in)	N/A	N/A	DWS Provided?	N/A		
N/A	Landing Width (in)	N/A	N/A	DWS Contrast?	N/A		
N/A	Landing Slope (%)	N/A	N/A	DWS Length (in)	N/A		
N/A	Landing X Slope (%)	N/A	N/A	DWS Full Width?	N/A		
N/A	Landing Curb? (Y/N)	N/A	N/A	DWS Offset (in)	N/A		
N/A	Shared Landing?	N/A					
N/A	Gutter Ponding?	N/A	N/A	Gutter Slope (%)	N/A		
N/A	Gutter Lip Ht (in)	N/A	N/A	Gutter X Slope (%)	N/A		
N/A	Painted X Walk1?	Yes	N/A	Painted X Walk2?	N/A		
	X Walk 1 Direction	To NE		X Walk 2 Direction	N/A		
N/A	X Walk 1 Width (in)	114.0	N/A	X Walk 2 Width (in)	N/A

X Walk 1 Slope (%)	1.8		X Walk 2 Slope (%)	N/A		
	X Walk 1 X Slope (%)	3.3		X Walk 2 X Slope (%)	N/A		
N/A	Ramp inside XWalk1?	Yes	N/A	Ramp inside XWalk2?	N/A		
	Road Slope (%)	N/A	N/A	Clear Space?	N/A		
	Road X Slope (%)	N/A	N/A	Clear Space to XWalk (in)	N/A		
N/A	Any Obstructions?	N/A	N/A	Storm Grate/Utility Hazard?	N/A		
	Obstruction Type			Storm Grate/Utility Type			
		N/A			N/A		
			Yes	Surface Condition? (G/P)	Good		
kl /

Possible Solutions: Remove & Replace Entire Ramp. Surveyor Notes: N/A PROW/ADA: Not Found, R304.5.1, R304.5.3
