Intersection ID: 18728	Main Street: RANDOLPH_RD	Cross Street: WONDERWOOD_DR	Location:	SW
ADA ID: 9F6A796A95B2	Ramp Type: Perp	Initial Pass/Fail: Fail	Overall Compliance: No	Severity Score: 13.75

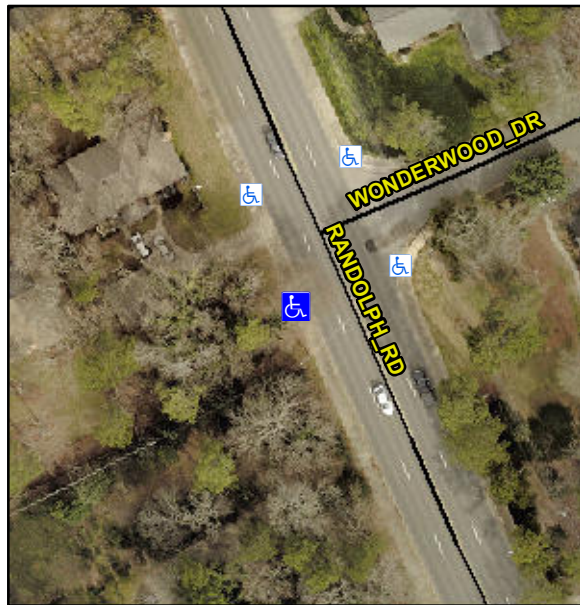
Not Found, R304.2.2, R304.5.3

Compliance	Description	Data	Compliance	Description	Data
N/A	Ramp Length (in)	71.5	No	Ramp Slope (%)	11.2
Yes	Ramp Width (in)	48.0	No	Ramp XSlope (%)	2.6
N/A	Flare Type LT	N/A	N/A	Flare Type RT	N/A
N/A	Flare Slope LT (%)	N/A	N/A	Flare Slope RT (%)	N/A
N/A	Flare Traversable LT?	N/A	N/A	Flare Traversable RT?	N/A
N/A	Landing Length (in)	N/A	N/A	DWS Provided?	N/A
N/A	Landing Width (in)	N/A	N/A	DWS Contrast?	N/A
N/A	Landing Slope (%)	N/A	N/A	DWS Length (in)	N/A
N/A	Landing X Slope (%)	N/A	N/A	DWS Full Width?	N/A
N/A	Landing Curb? (Y/N)	N/A	N/A	DWS Offset (in)	N/A
N/A	Shared Landing?	N/A			
N/A	Gutter Ponding?	Yes	N/A	Gutter Slope (%)	N/A
N/A	Gutter Lip Ht (in)	N/A	N/A	Gutter X Slope (%)	N/A
N/A	Painted X Walk1?	No	N/A	Painted X Walk2?	N/A
	X Walk 1 Direction	To E		X Walk 2 Direction	N/A
N/A	X Walk 1 Width (in)	N/A	N/A	X Walk 2 Width (in)	N/A
	X Walk 1 Slope (%)	0.6		X Walk 2 Slope (%)	N/A
	X Walk 1 X Slope (%)	0.2		X Walk 2 X Slope (%)	N/A

N/A	Ramp inside XWalk1?	N/A	N/A	Ramp inside XWalk2?	N/A
	Road Slope (%)	N/A	N/A	Clear Space?	N/A
	Road X Slope (%)	N/A	N/A	Clear Space to XWalk (in)	N/A
N/A	Any Obstructions?	N/A	N/A	Storm Grate/Utility Hazard?	N/A
	Obstruction Type			Storm Grate/Utility Type	
		N/A			N/A
			Yes	Surface Condition? (G/P)	Good

Remove & Replace Entire Ramp.
