# Access Compliance Report

## Public Rights-of-Way

### (Curb Ramps)

Intersection ID: N/A	Main Street: TRYON_ST	Cross Street: DIAMOND_CREEK_CIR	Location: S
ADA ID: 9F6B0A04DAAC	Ramp Type: PerpDiag	Initial Pass/Fail: Fail	Overall Compliance: No
Severity Score: 46.25			
Codes/Mitigation Info/Possible Solution		Field Measurements/Component Compliance

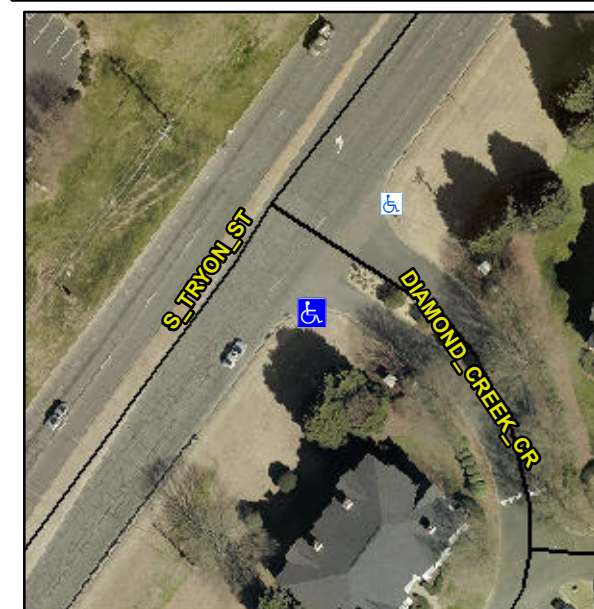
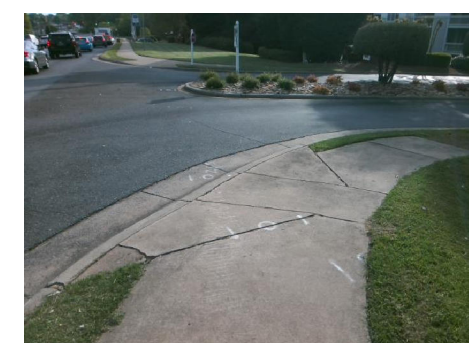
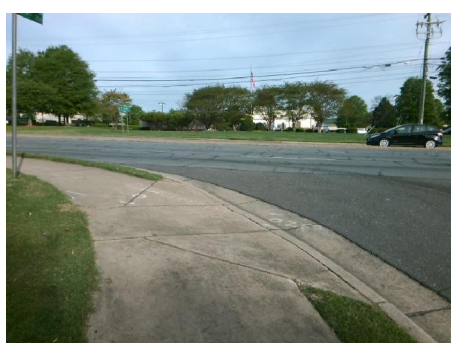
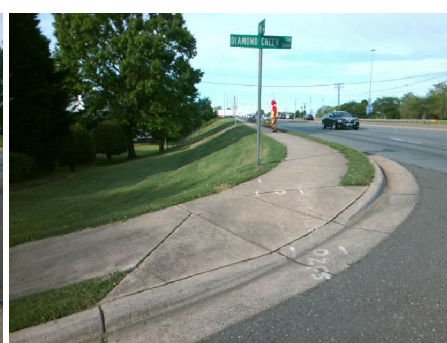
**Not Found, R304.5.1, R304.2.2, R304.5.3**

Compliance	Description	Data	Compliance	Description	Data
N/A	Ramp Length (in)	77.0	No	Ramp Slope (%)	9.2
No	Ramp Width (in)	46.0	No	Ramp XSlope (%)	11.2
N/A	Flare Type LT	N/A	N/A	Flare Type RT	N/A
N/A	Flare Slope LT (%)	N/A	N/A	Flare Slope RT (%)	N/A
N/A	Flare Traversable LT?	N/A	N/A	Flare Traversable RT?	N/A
N/A	Landing Length (in)	N/A	N/A	DWS Provided?	N/A
N/A	Landing Width (in)	N/A	N/A	DWS Contrast?	N/A
N/A	Landing Slope (%)	N/A	N/A	DWS Length (in)	N/A
N/A	Landing X Slope (%)	N/A	N/A	DWS Full Width?	N/A
N/A	Landing Curb? (Y/N)	N/A	N/A	DWS Offset (in)	N/A
N/A	Shared Landing?	N/A			
N/A	Gutter Ponding?	N/A	N/A	Gutter Slope (%)	N/A
N/A	Gutter Lip Ht (in)	N/A	N/A	Gutter X Slope (%)	N/A
N/A	Painted X Walk1?	No	N/A	Painted X Walk2?	No
	X Walk 1 Direction	To NE		X Walk 2 Direction	To NW
N/A	X Walk 1 Width (in)	N/A	N/A	X Walk 2 Width (in)	N/A
	X Walk 1 Slope (%)	9.3		X Walk 2 Slope (%)	8.6
	X Walk 1 X Slope (%)	2.3		X Walk 2 X Slope (%)	1.5

N/A	Ramp inside XWalk1?	N/A	N/A	Ramp inside XWalk2?	N/A
	Road Slope (%)	8.2	N/A	Clear Space?	N/A
	Road X Slope (%)	4.8	N/A	Clear Space to XWalk (in)	N/A
N/A	Any Obstructions?	N/A	N/A	Storm Grate/Utility Hazard?	N/A
	Obstruction Type			Storm Grate/Utility Type	
		N/A			N/A
			Yes	Surface Condition? (G/P)	Good

Possible Solutions:

**Remove & Replace Curb Ramp With Two New Directional Ramps or Equivalent.**
