Intersection ID: 10025677		Main Street: EAST_BV		Cross Street: N/A		Location:		SW	
ADA ID: 9F74C5B65927		Ramp Type: Perp		Initial Pass/Fail: Pass		Overall Compliance: No		Severity Score: 0	
Codes/Mitigation Info/Possible Solution				Field Measurements/Component Compliance

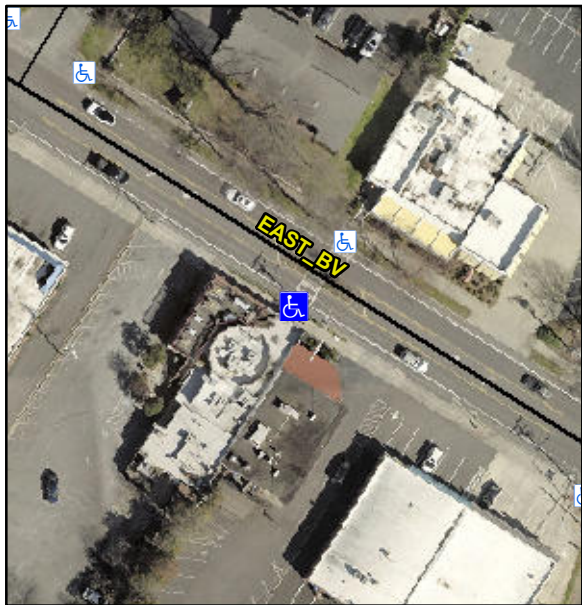
Possible Solutions:		Compliance		Description		Data	
		Remove & Replace Landing.		N/A		Ramp Length (in)		63.0	
				Yes		Ramp Width (in)		48.0	
				N/A		Flare Type LT		Sloped	
				N/A		Flare Slope LT (%)		1.0	
				N/A		Flare Traversable LT?		Yes	
				No		Landing Length (in)		35.0	
				Yes		Landing Width (in)		48.0	
				No		Landing Slope (%)		2.2	
				No		Landing X Slope (%)		2.6	
Surveyor Notes:  N/A		PROW/ADA:		N/A		Landing Curb? (Y/N)		Yes	
				N/A		Shared Landing?		No	
				Yes		Gutter Ponding?		No	
				Yes		Gutter Lip Ht (in)		0.0	
				N/A		Painted X Walk1?		Yes	
						X Walk 1 Direction		To NE	
				N/A		X Walk 1 Width (in)		114.0

X Walk 1 Slope (%)		4.0	
						X Walk 1 X Slope (%)		2.5	
				Yes		Ramp inside XWalk1?		Yes	
Total Cost: \$ 500.00				N/A		Road Slope (%)		N/A	
				N/A		Road X Slope (%)		N/A	
				Yes		Any Obstructions?		No	
						Obstruction Type			
								N/A	
								Yes	
								Surface Condition? (G/P)	
								Good
