Access Compliance Report

Public Rights-of-Way

(Curb Ramps)

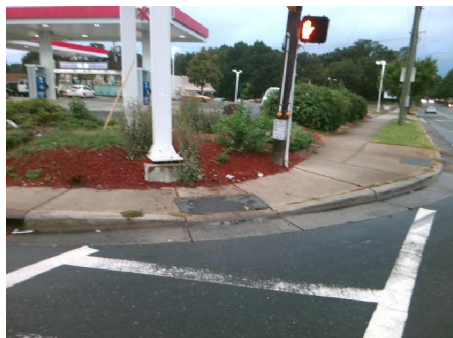
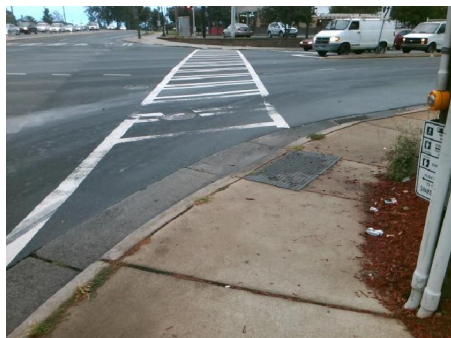
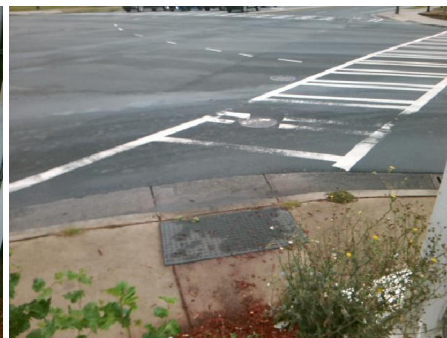
Intersection ID: 14442	Main Street: N_SHARON_AMITY_RD	Cross Street: CENTRAL_AV	Location: SW
ADA ID: 9F8274800FDF	Ramp Type: Para	Initial Pass/Fail: Fail	Overall Compliance: No
Severity Score: 13.75			
Codes/Mitigation Info/Possible Solution		Field Measurements/Component Compliance

Compliance	Description	Data	Compliance	Description	Data
N/A	Ramp Length LT (in)	58.0	N/A	Ramp Length RT (in)	62.0
Yes	Ramp Width LT (in)	51.0	Yes	Ramp Width RT (in)	63.5
Yes	Ramp Slope LT (%)	5.0	No	Ramp Slope RT (%)	8.5
Yes	Ramp XSlope LT (%)	1.0	No	Ramp XSlope RT (%)	2.3
N/A	Landing Length (in)	N/A	N/A	DWS Provided?	N/A
N/A	Landing Width (in)	N/A	N/A	DWS Contrast?	N/A
N/A	Landing Slope (%)	N/A	N/A	DWS Length (in)	N/A
N/A	Landing X Slope (%)	N/A	N/A	DWS Full Width?	N/A
N/A	Landing Curb? (Y/N)	N/A	N/A	DWS Offset (in)	N/A
N/A	Shared Landing?	N/A			
N/A	Gutter Ponding?	N/A	N/A	Gutter Slope (%)	N/A
N/A	Gutter Lip Ht (in)	N/A	N/A	Gutter X Slope (%)	N/A
N/A	Painted X Walk1?	Yes	N/A	Painted X Walk2?	N/A
	X Walk 1 Direction	To E		X Walk 2 Direction	N/A
N/A	X Walk 1 Width (in)	90.0	N/A	X Walk 2 Width (in)	N/A
	X Walk 1 Slope (%)	2.4		X Walk 2 Slope (%)	N/A
	X Walk 1 X Slope (%)	0.4		X Walk 2 X Slope (%)	N/A
N/A	Ramp inside XWalk1?	Yes	N/A	Ramp inside XWalk2?	N/A

Road Slope (%)	N/A	N/A	Clear Space?	N/A
	Road X Slope (%)	N/A	N/A	Clear Space to XWalk (in)	N/A
N/A	Any Obstructions?	N/A	N/A	Storm Grate/Utility Hazard?	N/A
	Obstruction Type			Storm Grate/Utility Type	
		N/A			N/A
			Yes	Surface Condition? (G/P)	Good
			N/A	Curb Slope (%)	21.5

Remove & Replace Entire Ramp.
