Access Compliance Report Public Rights-of-Way (Curb Ramps)

Intersection ID: 15402 Main Street: MARSH_RD Cross Street: NEW_BERN_ST Location: N

ADA ID: 9F8C5C648571 Ramp Type: Perp Initial Pass/Fail: Fail Overall Compliance: No Severity Score: 12.5

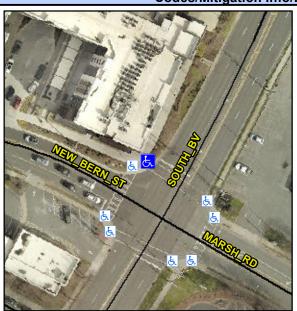
Field Measurements/Component Compliance						
Compl	iance Description	Data	Comp	liance Description	Data	
N/A	Ramp Length (in)	24.0	No	Ramp Slope (%)	9.4	
Yes	Ramp Width (in)	48.0	Yes	Ramp XSlope (%)	1.0	
N/A	Flare Type LT	N/A	N/A	Flare Type RT	N/A	
N/A	Flare Slope LT (%)	N/A	N/A	Flare Slope RT (%)	N/A	
N/A	Flare Traversable LT?	N/A	N/A	Flare Traversable RT?	N/A	
N/A	Landing Length (in)	N/A	N/A	DWS Provided?	N/A	
N/A	Landing Width (in)	N/A	N/A	DWS Contrast?	N/A	
N/A	Landing Slope (%)	N/A	N/A	DWS Length (in)	N/A	
N/A	Landing X Slope (%)	N/A	N/A	DWS Full Width?	N/A	
N/A	Landing Curb? (Y/N)	N/A	N/A	DWS Offset (in)	N/A	
N/A	Shared Landing?	N/A				
N/A	Gutter Ponding?	N/A	N/A	Gutter Slope (%)	N/A	
N/A	Gutter Lip Ht (in)	N/A	N/A	Gutter X Slope (%)	N/A	
N/A	Painted X Walk1?	Yes	N/A	Painted X Walk2?	N/A	
	X Walk 1 Direction	To SE		X Walk 2 Direction	N/A	
N/A	X Walk 1 Width (in)	110.0	N/A	X Walk 2 Width (in)	N/A	
	X Walk 1 Slope (%)	1.1		X Walk 2 Slope (%)	N/A

X Walk 1 X Slope (%)	1.0		X Walk 2 X Slope (%)	N/A	
N/A	Ramp inside XWalk1?	Yes	N/A	Ramp inside XWalk2?	N/A	
	Road Slope (%)	N/A	N/A	Clear Space?	N/A	
	Road X Slope (%)	N/A	N/A	Clear Space to XWalk (in)	N/A	
N/A	Any Obstructions?	N/A	N/A	Storm Grate/Utility Hazard?	N/A	
	Obstruction Type		l	Storm Grate/Utility Type		
		N/A			N/A	
			Yes	Surface Condition? (G/P)	Good

1 CCCIDIC CCIGNON	
Possible Solutions:	Co
Remove & Replace Entire Ramp.	N/A
•	Ye
	N/A
	N/A
	N/A
	N/A
Surveyor Notes:	N/A
N/A	N/A
	N/A
	N/A
	N/A
PROW/ADA:	N/A
Not Found, R304.2.2	N/A
	N/A
	N//
	N/A
