Access Compliance Report

Public Rights-of-Way

(Curb Ramps)

Intersection ID: 46589	Main Street: RABBITS FOOT LN	Cross Street: FERNHILL DR	Location:	N
ADA ID: 9F904A610F62	Ramp Type: BlendTrans2	Initial Pass/Fail: Fail	Overall Compliance: No	Severity Score: 21.25
Codes/Mitigation Info/Possible Solution		Field Measurements/Component Compliance

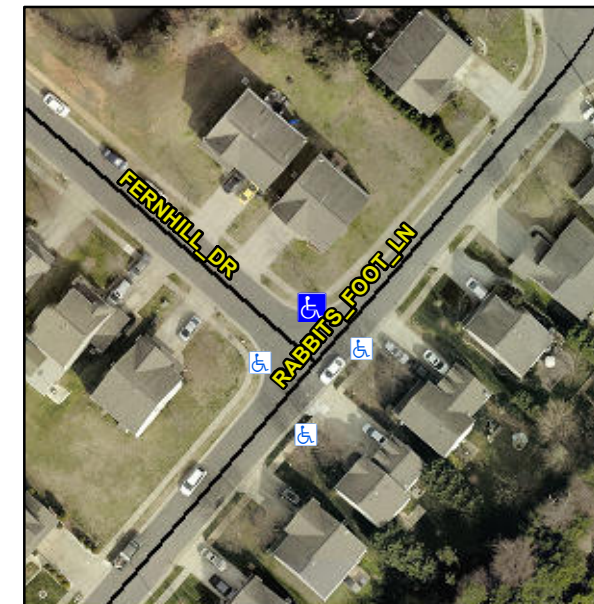
Not Found, R304.5.1, R304.5.3

Compliance	Description	Data	Compliance	Description	Data
N/A	Ramp Length (in)	93.0	Yes	BlendTrans Slope (%)	4.5
No	Ramp Width (in)	47.0	No	BlendTrans XSlope (%)	6.3
N/A	Flare Type LT	N/A	N/A	Flare Type RT	N/A
N/A	Flare Slope LT (%)	N/A	N/A	Flare Slope RT (%)	N/A
N/A	Flare Traversable LT?	N/A	N/A	Flare Traversable RT?	N/A
N/A	Landing Length (in)	N/A	N/A	DWS Provided?	N/A
N/A	Landing Width (in)	N/A	N/A	DWS Contrast?	N/A
N/A	Landing Slope (%)	N/A	N/A	DWS Length (in)	N/A
N/A	Landing X Slope (%)	N/A	N/A	DWS Full Width?	N/A
N/A	Landing Curb? (Y/N)	N/A	N/A	DWS Offset (in)	N/A
N/A	Shared Landing?	N/A			
N/A	Gutter Ponding?	N/A	N/A	Gutter Slope (%)	N/A
N/A	Gutter Lip Ht (in)	N/A	N/A	Gutter X Slope (%)	N/A
N/A	Painted X Walk1?	No	N/A	Painted X Walk2?	No
	X Walk 1 Direction	To SW		X Walk 2 Direction	To SE
	X Walk 1 Width (in)	N/A		X Walk 2 Width (in)	N/A
	X Walk 1 Slope (%)	0.1		X Walk 2 Slope (%)	4.1
	X Walk 1 X Slope (%)	4.6		X Walk 2 X Slope (%)	0.8

N/A	Ramp inside XWalk1?	N/A	N/A	Ramp inside XWalk2?	N/A
	Road Slope (%)	4.5		Clear Space?	N/A
	Road X Slope (%)	1.3	N/A	Clear Space to XWalk (in)	N/A
N/A	Any Obstructions?	N/A	N/A	Storm Grate/Utility Hazard?	N/A
	Obstruction Type			Storm Grate/Utility Type	
		N/A			N/A
			Yes	Surface Condition? (G/P)	Good
			No	Curb Slope (%)	11.6

Remove & Replace Curb Ramp With Two New Directional Ramps or Equivalent.
