Access Compliance Report Public Rights-of-Way (Curb Ramps)

Intersection ID: 4753 Main Street: LOWEN RD Cross Street: SADDLE TRAIL LN Location: NW **Overall Compliance: No** ADA ID: 9F93EC236628 Ramp Type: PerpDiag Initial Pass/Fail: Fail Severity Score: 18.75

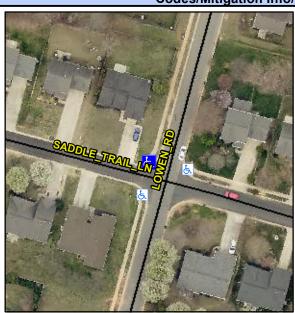
SADDLE TRAIL LN Street 1 Name Stop Condition-Street 2 StopSign **LOWEN RD** Street 2 Name Stop Condition-Street 1 None Possible Solutions: Remove & Replace Curb Ramp With Two New Directional Ramps or Equivalent. Surveyor Notes: N/A PROW/ADA: Not Found, R304.5.1, R304.5.3
