Access Compliance Report

Public Rights-of-Way

(Curb Ramps)

Intersection ID: 44487	Main Street: REAMES_RD	Cross Street: FINN_HALL_AV	Location: W
ADA ID: 9F987BCC9EDB	Ramp Type: Perp	Initial Pass/Fail: Fail	Overall Compliance: No
			Severity Score: 21.25

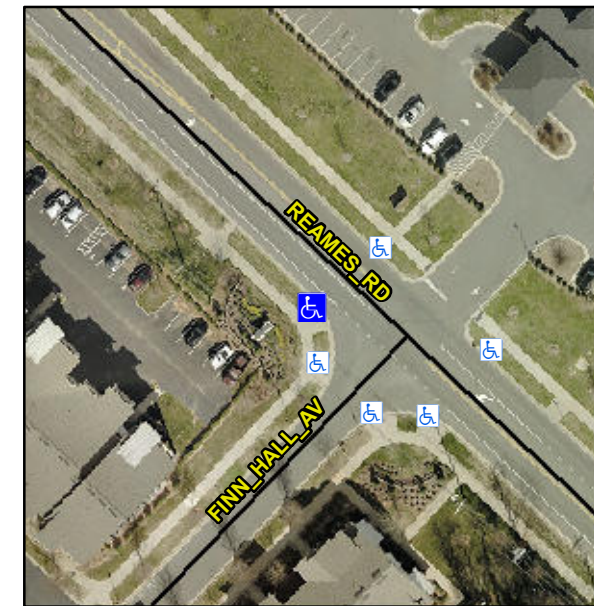
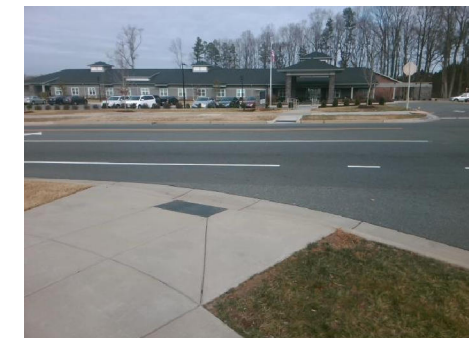
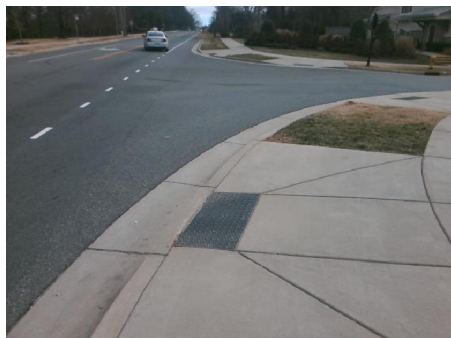
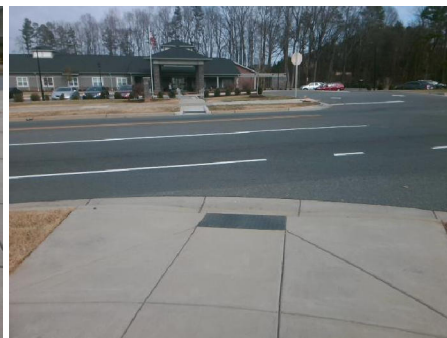
Not Found, R304.5.1, R304.5.3

Compliance	Description	Data	Compliance	Description	Data
N/A	Ramp Length (in)	96.0	Yes	Ramp Slope (%)	7.9
No	Ramp Width (in)	44.0	No	Ramp XSlope (%)	5.1
N/A	Flare Type LT	N/A	N/A	Flare Type RT	N/A
N/A	Flare Slope LT (%)	N/A	N/A	Flare Slope RT (%)	N/A
N/A	Flare Traversable LT?	N/A	N/A	Flare Traversable RT?	N/A
N/A	Landing Length (in)	N/A	N/A	DWS Provided?	N/A
N/A	Landing Width (in)	N/A	N/A	DWS Contrast?	N/A
N/A	Landing Slope (%)	N/A	N/A	DWS Length (in)	N/A
N/A	Landing X Slope (%)	N/A	N/A	DWS Full Width?	N/A
N/A	Landing Curb? (Y/N)	N/A	N/A	DWS Offset (in)	N/A
N/A	Shared Landing?	N/A			
N/A	Gutter Ponding?	N/A	N/A	Gutter Slope (%)	N/A
N/A	Gutter Lip Ht (in)	N/A	N/A	Gutter X Slope (%)	N/A
N/A	Painted X Walk1?	No	N/A	Painted X Walk2?	N/A
	X Walk 1 Direction	To N		X Walk 2 Direction	N/A
N/A	X Walk 1 Width (in)	N/A	N/A	X Walk 2 Width (in)	N/A
	X Walk 1 Slope (%)	7.3		X Walk 2 Slope (%)	N/A
	X Walk 1 X Slope (%)	5.0		X Walk 2 X Slope (%)	N/A

Remove & Replace Entire Ramp.
