Access Compliance Report Public Rights-of-Way (Curb Ramps)

Intersection ID: 29551Main Street:WHITEHALL_PARK_DRCross Street:ARCO_CORPORATE_DRLocation:SEADA ID: 9F9976363698Ramp Type:PerpDiagInitial Pass/Fail:FailOverall Compliance:NoSeverity Score:21.25

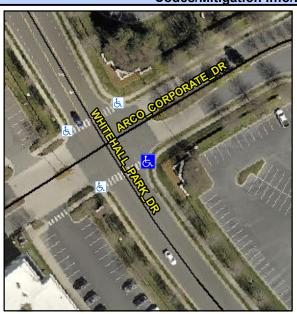
Field Measurements/Component Compilance					
Compliance Description		Data	Compliance Description		Data
N/A	Ramp Length (in)	48.0	No	Ramp Slope (%)	10.6
No	Ramp Width (in)	38.0	Yes	Ramp XSlope (%)	0.2
N/A	Flare Type LT	N/A	N/A	Flare Type RT	N/A
N/A	Flare Slope LT (%)	N/A	N/A	Flare Slope RT (%)	N/A
N/A	Flare Traversable LT?	N/A	N/A	Flare Traversable RT?	N/A
N/A	Landing Length (in)	N/A	N/A	DWS Provided?	N/A
N/A	Landing Width (in)	N/A	N/A	DWS Contrast?	N/A
N/A	Landing Slope (%)	N/A	N/A	DWS Length (in)	N/A
N/A	Landing X Slope (%)	N/A	N/A	DWS Full Width?	N/A
N/A	Landing Curb? (Y/N)	N/A	N/A	DWS Offset (in)	N/A
N/A	Shared Landing?	N/A			
N/A	Gutter Ponding?	N/A	N/A	Gutter Slope (%)	N/A
N/A	Gutter Lip Ht (in)	N/A	N/A	Gutter X Slope (%)	N/A
N/A	Painted X Walk1?	No	N/A	Painted X Walk2?	Yes
	X Walk 1 Direction	To NW		X Walk 2 Direction	To W
N/A	X Walk 1 Width (in)	N/A	N/A	X Walk 2 Width (in)	94.0
	X Walk 1 Slope (%)	2.7		X Walk 2 Slope (%)	5.4

X Walk 1 X Slope (%)	3.8		X Walk 2 X Slope (%)	0.8
N/A	Ramp inside XWalk1?	N/A	N/A	Ramp inside XWalk2?	Yes
	Road Slope (%)	2.0	N/A	Clear Space?	N/A
	Road X Slope (%)	3.5	N/A	Clear Space to XWalk (in)	N/A
N/A	Any Obstructions?	N/A	N/A	Storm Grate/Utility Hazard?	N/A
	Obstruction Type			Storm Grate/Utility Type	
		N/A			N/A
			Yes	Surface Condition? (G/P)	Good

Remove & Replace Curb Ramp With
Two New Directional Ramps or
Equivalent.

PROW/ADA:
R304.5.1, R304.2.2
