# Access Compliance Report

## Public Rights-of-Way (Curb Ramps)

Intersection ID: 50586	Main Street: LONGSTRAW_RD	Cross Street: DOWNY_BIRCH_RD	Location: NW
ADA ID: 9F9D692D630E	Ramp Type: Perp	Initial Pass/Fail: Fail	Overall Compliance: No
		Severity Score: 1.25

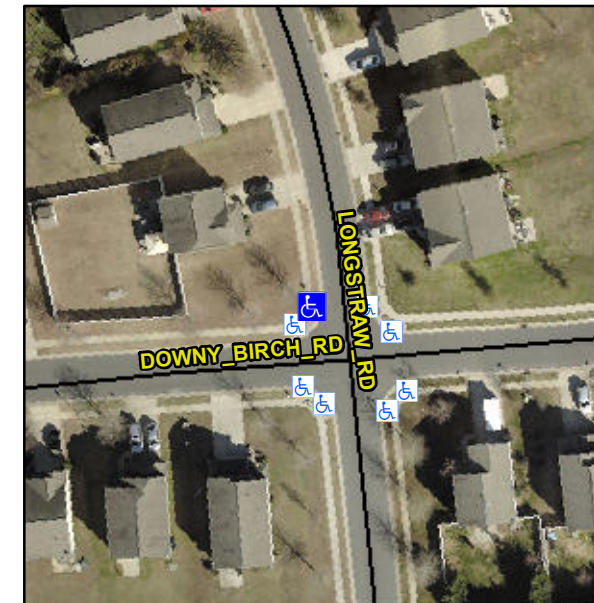
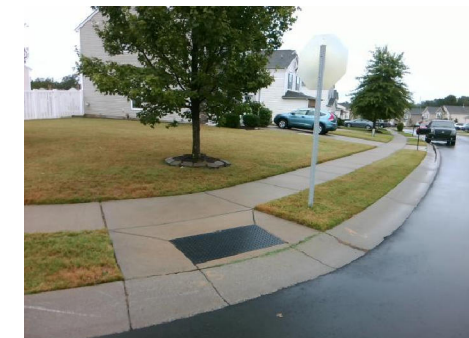
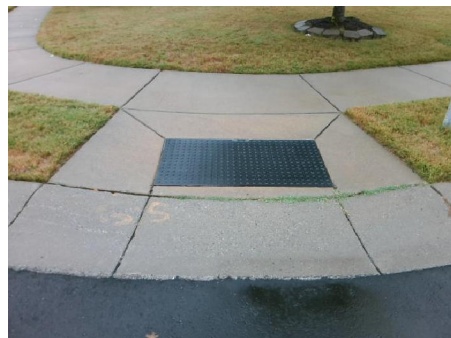
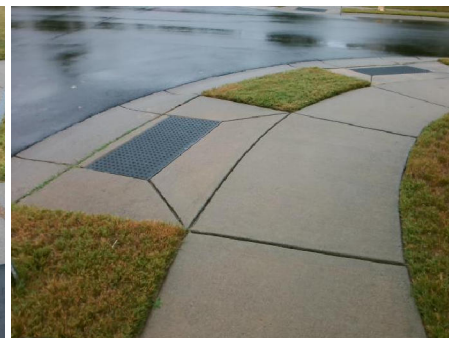
**Not Found, R304.5.3**

Compliance	Description	Data	Compliance	Description	Data
N/A	Ramp Length (in)	49.5	Yes	Ramp Slope (%)	6.8
Yes	Ramp Width (in)	48.0	No	Ramp XSlope (%)	2.3
N/A	Flare Type LT	N/A	N/A	Flare Type RT	N/A
N/A	Flare Slope LT (%)	N/A	N/A	Flare Slope RT (%)	N/A
N/A	Flare Traversable LT?	N/A	N/A	Flare Traversable RT?	N/A
N/A	Landing Length (in)	N/A	N/A	DWS Provided?	N/A
N/A	Landing Width (in)	N/A	N/A	DWS Contrast?	N/A
N/A	Landing Slope (%)	N/A	N/A	DWS Length (in)	N/A
N/A	Landing X Slope (%)	N/A	N/A	DWS Full Width?	N/A
N/A	Landing Curb? (Y/N)	N/A	N/A	DWS Offset (in)	N/A
N/A	Shared Landing?	N/A			
N/A	Gutter Ponding?	N/A	N/A	Gutter Slope (%)	N/A
N/A	Gutter Lip Ht (in)	N/A	N/A	Gutter X Slope (%)	N/A
N/A	Painted X Walk1?	No	N/A	Painted X Walk2?	N/A
	X Walk 1 Direction	To E		X Walk 2 Direction	N/A
N/A	X Walk 1 Width (in)	N/A	N/A	X Walk 2 Width (in)	N/A
	X Walk 1 Slope (%)	2.4		X Walk 2 Slope (%)	N/A
	X Walk 1 X Slope (%)	2.7		X Walk 2 X Slope (%)	N/A

N/A	Ramp inside XWalk1?	N/A	N/A	Ramp inside XWalk2?	N/A
	Road Slope (%)	N/A	N/A	Clear Space?	N/A
	Road X Slope (%)	N/A	N/A	Clear Space to XWalk (in)	N/A
N/A	Any Obstructions?	N/A	N/A	Storm Grate/Utility Hazard?	N/A
	Obstruction Type			Storm Grate/Utility Type	
		N/A			N/A
		Yes		Surface Condition? (G/P)	Good

**Remove & Replace Entire Ramp.**

Total Cost: \$ 1850.00
