# Access Compliance Report

## Public Rights-of-Way

### (Curb Ramps)

Intersection ID: 25834	Main Street: PARK_RD	Cross Street: OSPREY_DR	Location: S
ADA ID: 9F9EE1015DFF	Ramp Type: PerpDiag	Initial Pass/Fail: Fail	Overall Compliance: No
			Severity Score: 46.25

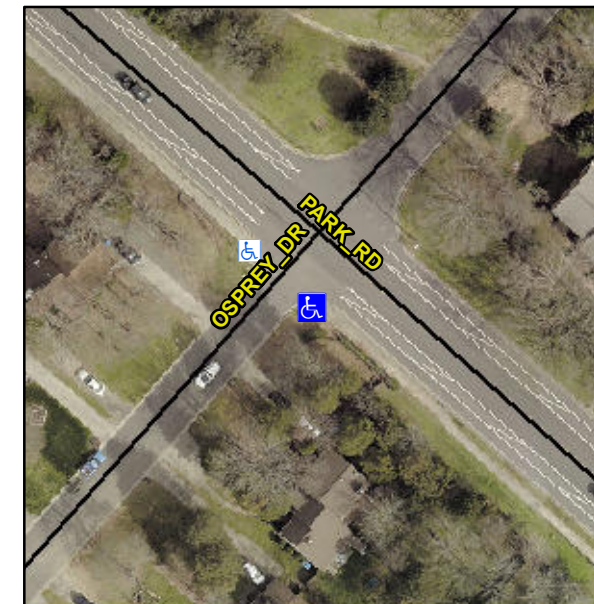
**Not Found, R304.5.1, R304.2.2, R304.5.3**

Compliance	Description	Data	Compliance	Description	Data
N/A	Ramp Length (in)	71.0	No	Ramp Slope (%)	8.7
No	Ramp Width (in)	46.0	No	Ramp XSlope (%)	10.4
N/A	Flare Type LT	N/A	N/A	Flare Type RT	N/A
N/A	Flare Slope LT (%)	N/A	N/A	Flare Slope RT (%)	N/A
N/A	Flare Traversable LT?	N/A	N/A	Flare Traversable RT?	N/A
N/A	Landing Length (in)	N/A	N/A	DWS Provided?	N/A
N/A	Landing Width (in)	N/A	N/A	DWS Contrast?	N/A
N/A	Landing Slope (%)	N/A	N/A	DWS Length (in)	N/A
N/A	Landing X Slope (%)	N/A	N/A	DWS Full Width?	N/A
N/A	Landing Curb? (Y/N)	N/A	N/A	DWS Offset (in)	N/A
N/A	Shared Landing?	N/A			
N/A	Gutter Ponding?	N/A	N/A	Gutter Slope (%)	N/A
N/A	Gutter Lip Ht (in)	N/A	N/A	Gutter X Slope (%)	N/A
N/A	Painted X Walk1?	No	N/A	Painted X Walk2?	No
	X Walk 1 Direction	To NE		X Walk 2 Direction	To NW
N/A	X Walk 1 Width (in)	N/A	N/A	X Walk 2 Width (in)	N/A
	X Walk 1 Slope (%)	0.1		X Walk 2 Slope (%)	5.4
	X Walk 1 X Slope (%)	4.9		X Walk 2 X Slope (%)	4.6

N/A	Ramp inside XWalk1?	N/A	N/A	Ramp inside XWalk2?	N/A
	Road Slope (%)	5.5	N/A	Clear Space?	N/A
	Road X Slope (%)	3.2	N/A	Clear Space to XWalk (in)	N/A
N/A	Any Obstructions?	N/A	N/A	Storm Grate/Utility Hazard?	N/A
	Obstruction Type			Storm Grate/Utility Type	
		N/A			N/A
			Yes	Surface Condition? (G/P)	Good

**Remove & Replace Curb Ramp With Two New Directional Ramps or Equivalent.**
