Access Compliance Report

Public Rights-of-Way

(Curb Ramps)

| Intersection ID: 21132 | Main Street: ARROWOOD_ST | Cross Street: SOUTHERN_PINE_BV | Location: W |

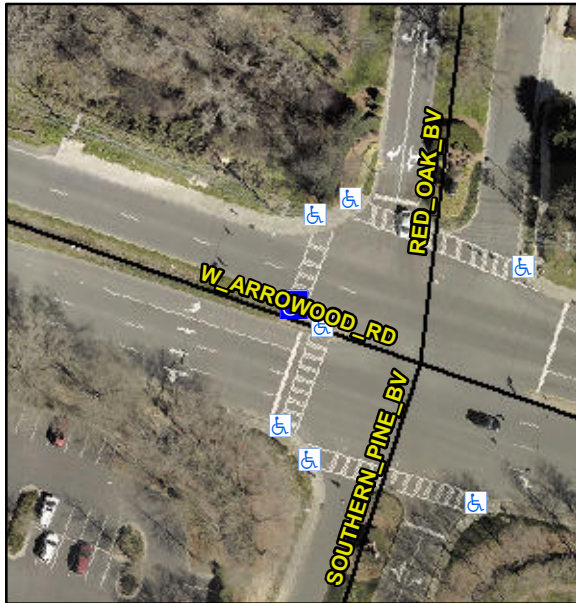
R304.2.2-Perp, R304.3.2-Para

| Compliance | Description | Data | Compliance | Description | Data |
|---|---|---|---|---|---|
| No | Landing Slope (%) | 2.6 | Yes | DWS Length (in) | 24.0 |

Remove & Replace Landing.
