Access Compliance Report

Public Rights-of-Way

(Curb Ramps)

Intersection ID: 46303	Main Street: HONEY_CREEK_LN	Cross Street: MERMANS_RD	Location: SE
ADA ID: 9FADFA02A4A0	Ramp Type: PerpDiag	Initial Pass/Fail: Fail	Overall Compliance: No
Severity Score: 22.5			
Codes/Mitigation Info/Possible Solution		Field Measurements/Component Compliance

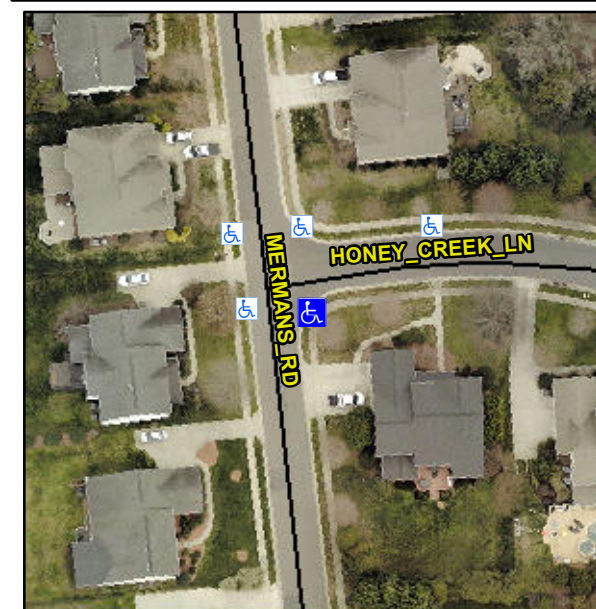
Not Found, R304.5.1, R304.2.2, R304.5.3

Compliance	Description	Data	Compliance	Description	Data
N/A	Ramp Length (in)	48.0	No	Ramp Slope (%)	10.9
No	Ramp Width (in)	47.5	No	Ramp XSlope (%)	2.3
N/A	Flare Type LT	N/A	N/A	Flare Type RT	N/A
N/A	Flare Slope LT (%)	N/A	N/A	Flare Slope RT (%)	N/A
N/A	Flare Traversable LT?	N/A	N/A	Flare Traversable RT?	N/A
N/A	Landing Length (in)	N/A	N/A	DWS Provided?	N/A
N/A	Landing Width (in)	N/A	N/A	DWS Contrast?	N/A
N/A	Landing Slope (%)	N/A	N/A	DWS Length (in)	N/A
N/A	Landing X Slope (%)	N/A	N/A	DWS Full Width?	N/A
N/A	Landing Curb? (Y/N)	N/A	N/A	DWS Offset (in)	N/A
N/A	Shared Landing?	N/A			
N/A	Gutter Ponding?	N/A	N/A	Gutter Slope (%)	N/A
N/A	Gutter Lip Ht (in)	N/A	N/A	Gutter X Slope (%)	N/A
N/A	Painted X Walk1?	No	N/A	Painted X Walk2?	No
	X Walk 1 Direction	To N		X Walk 2 Direction	To W
N/A	X Walk 1 Width (in)	N/A	N/A	X Walk 2 Width (in)	N/A
	X Walk 1 Slope (%)	5.6		X Walk 2 Slope (%)	0.7
	X Walk 1 X Slope (%)	0.6		X Walk 2 X Slope (%)	2.7

N/A	Ramp inside XWalk1?	N/A	N/A	Ramp inside XWalk2?	N/A
	Road Slope (%)	0.4	N/A	Clear Space?	N/A
	Road X Slope (%)	6.6	N/A	Clear Space to XWalk (in)	N/A
N/A	Any Obstructions?	N/A	N/A	Storm Grate/Utility Hazard?	N/A
	Obstruction Type			Storm Grate/Utility Type	
		N/A			N/A
			Yes	Surface Condition? (G/P)	Good

Possible Solutions:

Remove & Replace Curb Ramp With Two New Directional Ramps or Equivalent.
