Access Compliance Report

Public Rights-of-Way

(Curb Ramps)

Intersection ID: 23470	Main Street: BRANDON_FOREST_DR	Cross Street: STRADBROOK_DR	Location:	N
ADA ID: 9FB0E9F0B195	Ramp Type: Directional1	Initial Pass/Fail: Fail	Overall Compliance: No	Severity Score: 12.5
Codes/Mitigation Info/Possible Solution		Field Measurements/Component Compliance

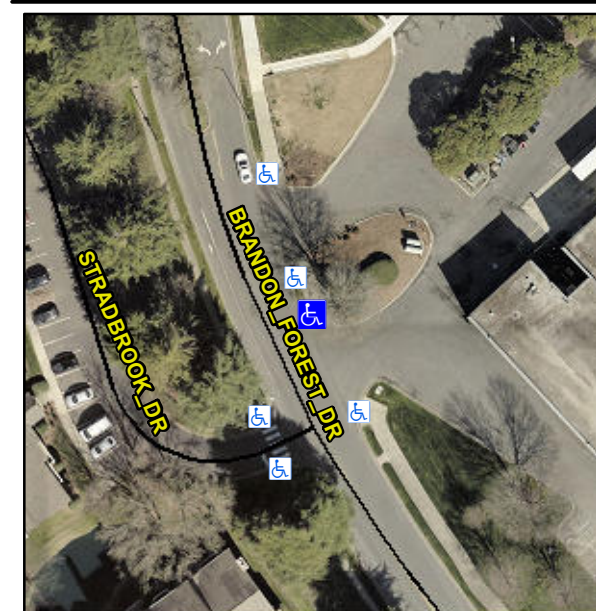
PROW/ADA:

R304.5.3

Compliance	Description	Data	Compliance	Description	Data
N/A	Ramp Length (in)	99.0	N/A	Grade Break?	N/A
Yes	Ramp Width (in)	97.0	N/A	Grade Break Slope (%)	0.0
Yes	Ramp Slope (%)	0.2	N/A	Grade Break XSlope (%)	0.0
No	Ramp XSlope (%)	5.1			
N/A	Flare Type LT	N/A	N/A	Flare Type RT	N/A
N/A	Flare Slope LT (%)	N/A	N/A	Flare Slope RT (%)	0.0
N/A	Flare Traversable LT?	N/A	N/A	Flare Traversable RT?	N/A
N/A	Landing Length (in)	0.0	N/A	DWS Provided?	N/A
N/A	Landing Width (in)	0.0	N/A	DWS Contrast?	N/A
N/A	Landing Slope (%)	0.0	N/A	DWS Length (in)	N/A
N/A	Landing X Slope (%)	0.0	N/A	DWS Full Width?	N/A
N/A	Landing Curb? (Y/N)	N/A	N/A	DWS Offset LT (in)	N/A
N/A	Shared Landing?	N/A	N/A	DWS Offset RT (in)	N/A
N/A	Gutter Ponding?	0.0	N/A	Gutter Slope (%)	N/A
N/A	Gutter Lip Ht (in)	0.0	N/A	Gutter X Slope (%)	N/A
N/A	Painted X Walk1?	No		Road Slope (%)	5.5
	X Walk 1 Direction	To SE		Road X Slope (%)	1.1
	X Walk 1 Width (in)	N/A		Clear Space?	N/A

X Walk 1 Slope (%)	5.5	N/A	Clear Space to XWalk (in)	N/A
	X Walk 1 X Slope (%)	1.1	N/A	Storm Grate/Utility Hazard?	N/A
N/A	Ramp inside XWalk1?	N/A		Storm Grate/Utility Type	
N/A	Any Obstructions?	N/A			N/A
	Obstruction Type		Yes	Surface Condition? (G/P)	Good
			N/A	Curb Slope (%)	3.5

Possible Solutions:

Remove & Replace Entire Ramp.

Total Cost: \$ 1600.00
