Access Compliance Report Public Rights-of-Way (Curb Ramps)

Intersection ID: 23917 Main Street: BOSHAM LN **Cross Street: WHITWORTH_WY** Location: NE **Overall Compliance: No** ADA ID: 9FD0DF23D45D Ramp Type: Perp Initial Pass/Fail: Fail Severity Score: 21.25

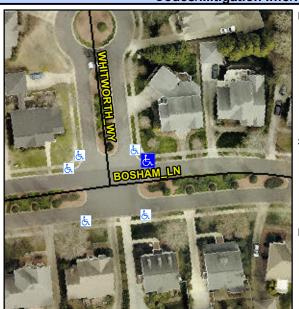
Comp	liance Description	Data	Comp	liance	Description	Data
N/A	Ramp Length (in)	44.0	No	Ramp	Slope (%)	9.0
No	Ramp Width (in)	47.0	Yes	Ramp	XSlope (%)	2.0
N/A	Flare Type LT	N/A	N/A	Flare	Type RT	N/A
N/A	Flare Slope LT (%)	N/A	N/A	Flare	Slope RT (%)	N/A
N/A	Flare Traversable LT?	N/A	N/A	Flare	Traversable RT?	N/A
N/A	Landing Length (in)	N/A	N/A	DWS	Provided?	N/A
N/A	Landing Width (in)	N/A	N/A	DWS	Contrast?	N/A
N/A	Landing Slope (%)	N/A	N/A	DWS	Length (in)	N/A
N/A	Landing X Slope (%)	N/A	N/A	DWS	Full Width?	N/A
N/A	Landing Curb? (Y/N)	N/A	N/A	DWS	Offset (in)	N/A
N/A	Shared Landing?	N/A				
N/A	Gutter Ponding?	N/A	N/A	Gutte	r Slope (%)	N/A
N/A	Gutter Lip Ht (in)	N/A	N/A	Gutte	r X Slope (%)	N/A
N/A	Painted X Walk1?	No	N/A	Paint	ed X Walk2?	N/A
	X Walk 1 Direction	To S		X Wa	lk 2 Direction	N/A
N/A	X Walk 1 Width (in)	N/A	N/A	X Wa	lk 2 Width (in)	N/A
	X Walk 1 Slope (%)	7.0		X Wa	lk 2 Slope (%)	N/A
	X Walk 1 X Slope (%)	0.7		X Wa	lk 2 X Slope (%)	N/A

N/A	Ramp inside XWalk1?	N/A	N/A	Ramp	inside XWalk2?	N/A
	Road Slope (%)	N/A	N/A	Clear	Space?	N/A
	Road X Slope (%)	N/A	N/A	Clear	Space to XWalk (in)	N/A
N/A	Any Obstructions?	N/A	N/A	Storm	n Grate/Utility Hazard?	N/A
	Obstruction Type			Storm	n Grate/Utility Type	
		N/A				N/A
			Yes	Surfa	ce Condition? (G/P)	Good

Possible Solutions:	
Remove & Replace Entire Ramp.	
Sun over Netec:	
Surveyor Notes:	
N/A	
PROW/ADA:	
Not Found, R304.5.1, R304.2.2	I

N/A
Surveyor Notes:				N/A
N/A				N/A
				N/A
				N/A
				N/A
PROW/ADA:				N/A
Not Found,	R304.5.1, R304.2	2.2		N/A
				N/A
				N/A
				N/A
Total Cost:	\$		1850.00	N/A
	•
