Access Compliance Report Public Rights-of-Way (Curb Ramps)

Intersection ID: 48763 Main Street: SONOMA_VALLEY_DR					Street:	N/A	Location:	w			
ADA ID: 9FD8D4DADB93 Ramp Type: Perp					ail: Fail Overall (1.25				
Codes/Mitigation Info/Possible Solution					Field Measurements/Component Compliance						
Possible Solutions:				Comr	liance Description	liance Description	Data				
May See	the second second		o Dom	-	N/A	Ramp Length (in)	<u>Data</u> 71.0	Yes	Ramp Slope (%)	<u>5.5</u>	
E.A. ANDER		Remove & Replace Entir	екат	p.	Yes	Ramp Width (in)	48.0		Ramp XSlope (%)	3.1	
					N/A	Flare Type LT	40.0 N/A		Flare Type RT	N/A	
					N/A	Flare Slope LT (%)		N/A	Flare Slope RT (%)	N/A	
					N/A	Flare Traversable LT?			Flare Traversable RT?	N/A	
					N/A	Landing Length (in)	N/A	N/A N/A	DWS Provided?	N/A N/A	
and a second second		Surveyor Notes:			N/A				DWS Frovided? DWS Contrast?	N/A	
						Landing Width (in)	N/A				
		N/A			N/A	Landing Slope (%)		N/A	DWS Length (in)	N/A	
		3			N/A	Landing X Slope (%)	N/A	N/A	DWS Full Width?	N/A

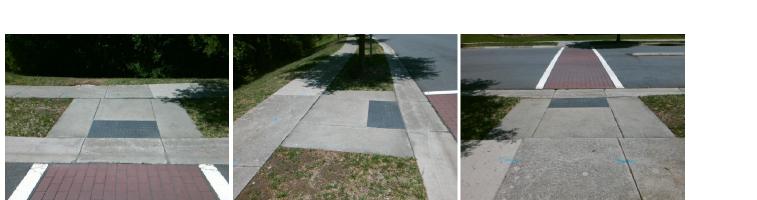
5. C	TURNING WHEEL DR	Not Found, R304.5.3			N/A	Gutter Lip Ht (in)	N/A	N/A	Gutter X Slope (%)	N/A	
					N/A	Painted X Walk1?	Yes	N/A	Painted X Walk2?	N/A
