# Access Compliance Report

## Public Rights-of-Way

### (Curb Ramps)

Intersection ID: 4017	Main Street: GALLOWAY_RD	Cross Street: KENDAN_KNOLL_DR	Location: SW
ADA ID: 9FEC3B99228F	Ramp Type: Perp	Initial Pass/Fail: Fail	Overall Compliance: No
Severity Score: 12.5			
Codes/Mitigation Info/Possible Solution		Field Measurements/Component Compliance

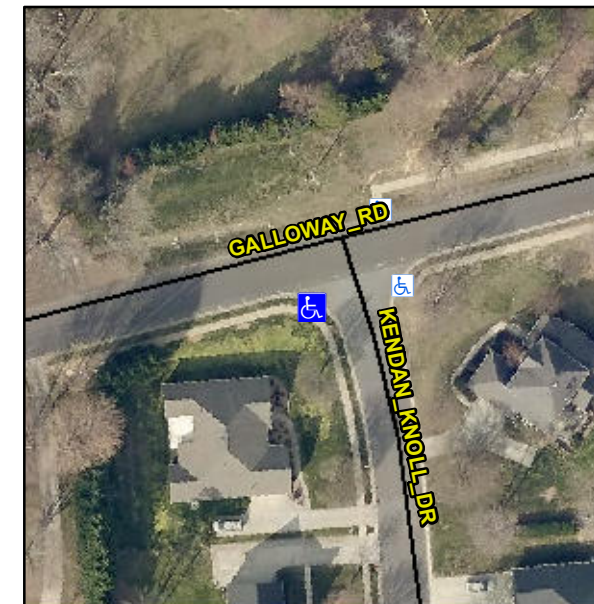
**Not Found, R304.2.2**

Compliance	Description	Data	Compliance	Description	Data
N/A	Ramp Length (in)	50.0	No	Ramp Slope (%)	9.6
Yes	Ramp Width (in)	48.0	Yes	Ramp XSlope (%)	1.8
N/A	Flare Type LT	N/A	N/A	Flare Type RT	N/A
N/A	Flare Slope LT (%)	N/A	N/A	Flare Slope RT (%)	N/A
N/A	Flare Traversable LT?	N/A	N/A	Flare Traversable RT?	N/A
N/A	Landing Length (in)	N/A	N/A	DWS Provided?	N/A
N/A	Landing Width (in)	N/A	N/A	DWS Contrast?	N/A
N/A	Landing Slope (%)	N/A	N/A	DWS Length (in)	N/A
N/A	Landing X Slope (%)	N/A	N/A	DWS Full Width?	N/A
N/A	Landing Curb? (Y/N)	N/A	N/A	DWS Offset (in)	N/A
N/A	Shared Landing?	N/A			
N/A	Gutter Ponding?	N/A	N/A	Gutter Slope (%)	N/A
N/A	Gutter Lip Ht (in)	N/A	N/A	Gutter X Slope (%)	N/A
N/A	Painted X Walk1?	No	N/A	Painted X Walk2?	N/A
	X Walk 1 Direction	To E		X Walk 2 Direction	N/A
N/A	X Walk 1 Width (in)	N/A	N/A	X Walk 2 Width (in)	N/A
	X Walk 1 Slope (%)	3.1		X Walk 2 Slope (%)	N/A
	X Walk 1 X Slope (%)	5.4		X Walk 2 X Slope (%)	N/A

N/A	Ramp inside XWalk1?	N/A	N/A	Ramp inside XWalk2?	N/A
	Road Slope (%)	N/A	N/A	Clear Space?	N/A
	Road X Slope (%)	N/A	N/A	Clear Space to XWalk (in)	N/A
N/A	Any Obstructions?	N/A	N/A	Storm Grate/Utility Hazard?	N/A
	Obstruction Type			Storm Grate/Utility Type	
		N/A			N/A
			Yes	Surface Condition? (G/P)	Good

**Remove & Replace Entire Ramp.**

Total Cost: \$ 1850.00
