Access Compliance Report

Public Rights-of-Way

(Curb Ramps)

Intersection ID: 10166	Main Street: OAKLAWN_AV	Cross Street: SPRING_ST	Location: SW
ADA ID: 9FF0B73B6367	Ramp Type: PerpDiag	Initial Pass/Fail: Fail	Overall Compliance: No
			Severity Score: 21.25

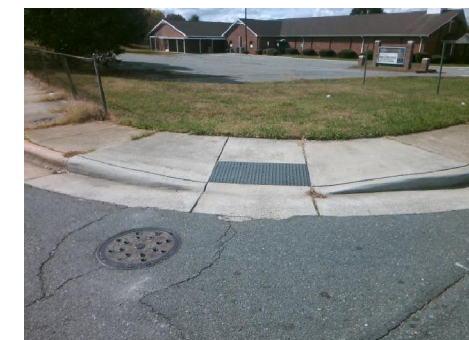
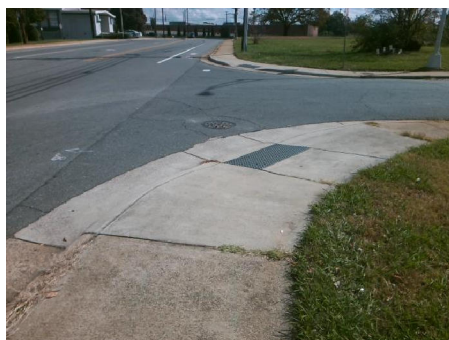
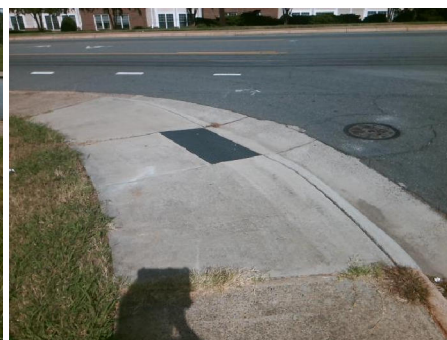
Not Found, R304.5.1, R304.2.2

Compliance	Description	Data	Compliance	Description	Data
N/A	Ramp Length (in)	67.0	No	Ramp Slope (%)	9.9
No	Ramp Width (in)	47.0	Yes	Ramp XSlope (%)	0.5
N/A	Flare Type LT	N/A	N/A	Flare Type RT	N/A
N/A	Flare Slope LT (%)	N/A	N/A	Flare Slope RT (%)	N/A
N/A	Flare Traversable LT?	N/A	N/A	Flare Traversable RT?	N/A
N/A	Landing Length (in)	N/A	N/A	DWS Provided?	N/A
N/A	Landing Width (in)	N/A	N/A	DWS Contrast?	N/A
N/A	Landing Slope (%)	N/A	N/A	DWS Length (in)	N/A
N/A	Landing X Slope (%)	N/A	N/A	DWS Full Width?	N/A
N/A	Landing Curb? (Y/N)	N/A	N/A	DWS Offset (in)	N/A
N/A	Shared Landing?	N/A			
N/A	Gutter Ponding?	N/A	N/A	Gutter Slope (%)	N/A
N/A	Gutter Lip Ht (in)	N/A	N/A	Gutter X Slope (%)	N/A
N/A	Painted X Walk1?	No	N/A	Painted X Walk2?	No
	X Walk 1 Direction	To E		X Walk 2 Direction	To N
N/A	X Walk 1 Width (in)	N/A	N/A	X Walk 2 Width (in)	N/A
	X Walk 1 Slope (%)	2.7		X Walk 2 Slope (%)	5.1
	X Walk 1 X Slope (%)	2.7		X Walk 2 X Slope (%)	2.3

N/A	Ramp inside XWalk1?	N/A	N/A	Ramp inside XWalk2?	N/A
	Road Slope (%)	0.2	N/A	Clear Space?	N/A
	Road X Slope (%)	4.2	N/A	Clear Space to XWalk (in)	N/A
N/A	Any Obstructions?	N/A	N/A	Storm Grate/Utility Hazard?	N/A
	Obstruction Type			Storm Grate/Utility Type	
		N/A			N/A
			Yes	Surface Condition? (G/P)	Good

Remove & Replace Curb Ramp With Two New Directional Ramps or Equivalent.
