# Access Compliance Report

## Public Rights-of-Way

### (Curb Ramps)

Intersection ID: 11610	Main Street: COLE_DR	Cross Street: GLENVILLE_AV	Location: NE
ADA ID: 9FF531260443	Ramp Type: ParaDiag	Initial Pass/Fail: Fail	Overall Compliance: No
Codes/Mitigation Info/Possible Solution		Field Measurements/Component Compliance	
Severity Score: 13.75

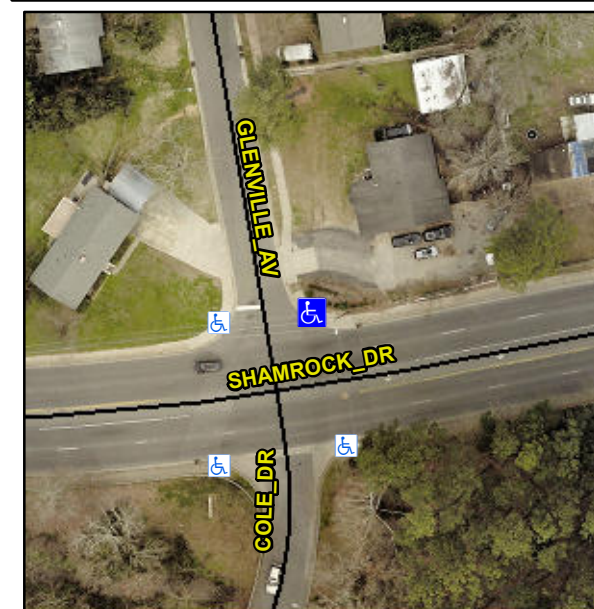
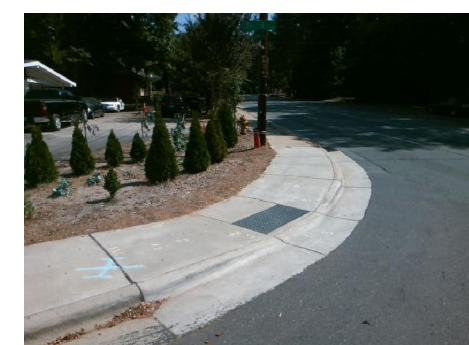
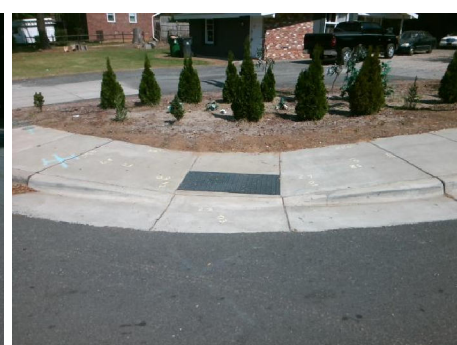
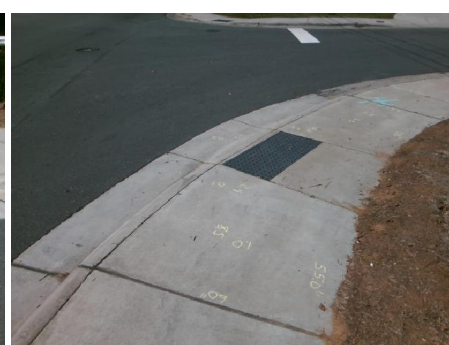
**LT RP < 5%**

Compliance	Description	Data	Compliance	Description	Data
N/A	Ramp Length LT (in)	58.0	N/A	Ramp Length RT (in)	55.0
Yes	Ramp Width LT (in)	59.5	Yes	Ramp Width RT (in)	60.0
Yes	Ramp Slope LT (%)	3.3	No	Ramp Slope RT (%)	8.5
No	Ramp XSlope LT (%)	2.8	Yes	Ramp XSlope RT (%)	1.0
N/A	Landing Length (in)	N/A	N/A	DWS Provided?	N/A
N/A	Landing Width (in)	N/A	N/A	DWS Contrast?	N/A
N/A	Landing Slope (%)	N/A	N/A	DWS Length (in)	N/A
N/A	Landing X Slope (%)	N/A	N/A	DWS Full Width?	N/A
N/A	Landing Curb? (Y/N)	N/A	N/A	DWS Offset (in)	N/A
N/A	Shared Landing?	N/A			
N/A	Gutter Ponding?	N/A	N/A	Gutter Slope (%)	N/A
N/A	Gutter Lip Ht (in)	N/A	N/A	Gutter X Slope (%)	N/A
N/A	Painted X Walk1?	No	N/A	Painted X Walk2?	No
	X Walk 1 Direction	To W		X Walk 2 Direction	To S
N/A	X Walk 1 Width (in)	N/A	N/A	X Walk 2 Width (in)	N/A
	X Walk 1 Slope (%)	4.2		X Walk 2 Slope (%)	0.1
	X Walk 1 X Slope (%)	0.3		X Walk 2 X Slope (%)	2.9
N/A	Ramp inside XWalk1?	N/A	N/A	Ramp inside XWalk2?	N/A

Road Slope (%)	2.2	N/A	Clear Space?	N/A
	Road X Slope (%)	0.3	N/A	Clear Space to XWalk (in)	N/A
N/A	Any Obstructions?	N/A	N/A	Storm Grate/Utility Hazard?	N/A
	Obstruction Type			Storm Grate/Utility Type	
		N/A			N/A
			Yes	Surface Condition? (G/P)	Good
			N/A	Curb Slope (%)	22.6

**Remove & Replace Curb Ramp With Two New Directional Ramps or Equivalent.**

**R304.5.3, R304.3.2**
