# Access Compliance Report

## Public Rights-of-Way

### (Curb Ramps)

| Intersection ID: 11980 | Main Street: ALLEN_ST | Cross Street: E_17TH_ST | Location: E |

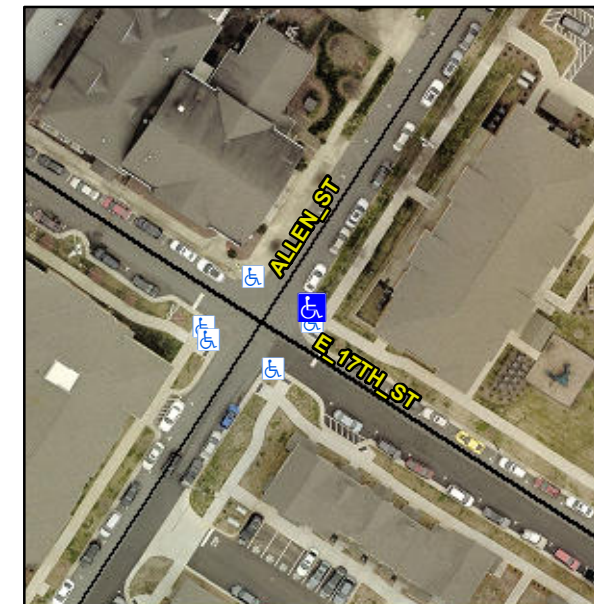
**R304.5.3, R305.1.4**

| Compliance | Description | Data | Compliance | Description | Data |
|---|---|---|---|---|---|
| Yes | Ramp Slope (%) | 4.0 | No | Grade Break XSlope (%) | 3.2 |
| Yes | Landing X Slope (%) | 0.0 | No | DWS Full Width? | No |
| Yes | Gutter Lip Ht (in) | 0.0 | No | Gutter X Slope (%) | 4.0 |

**Remove & Replace Entire Ramp.  
Remove & Replace Gutter.**
