Access Compliance Report Public Rights-of-Way (Curb Ramps)

Intersection ID: 11501 Main Street: FOXFORD PL Cross Street: SHAMROCK_DR Location: SE ADA ID: A00275161062 Ramp Type: Perp Initial Pass/Fail: Fail **Overall Compliance: No Severity Score:** 12.5

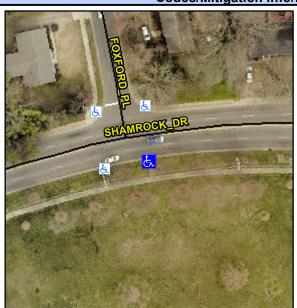
Field Measurements/Component Compilance						
Compliance Description Data			Comp	liance Description	Data	
N/A	Ramp Length (in)	215.0	Yes	Ramp Slope (%)	6.9	
Yes	Ramp Width (in)	48.0	No	Ramp XSlope (%)	5.	
N/A	Flare Type LT	N/A	N/A	Flare Type RT	N/A	
N/A	Flare Slope LT (%)	N/A	N/A	Flare Slope RT (%)	N/A	
N/A	Flare Traversable LT?	N/A	N/A	Flare Traversable RT?	N/A	
N/A	Landing Length (in)	N/A	N/A	DWS Provided?	N/A	
N/A	Landing Width (in)	N/A	N/A	DWS Contrast?	N/A	
N/A	Landing Slope (%)	N/A	N/A	DWS Length (in)	N/A	
N/A	Landing X Slope (%)	N/A	N/A	DWS Full Width?	N/A	
N/A	Landing Curb? (Y/N)	N/A	N/A	DWS Offset (in)	N/A	
N/A	Shared Landing?	N/A				
N/A	Gutter Ponding?	N/A	N/A	Gutter Slope (%)	N/A	
N/A	Gutter Lip Ht (in)	2.0	N/A	Gutter X Slope (%)	N/A	
N/A	Painted X Walk1?	No	N/A	Painted X Walk2?	N/A	
	X Walk 1 Direction	To N		X Walk 2 Direction	N/A	
N/A	X Walk 1 Width (in)	N/A	N/A	X Walk 2 Width (in)	N/A	
	X Walk 1 Slope (%)	4.8		X Walk 2 Slope (%)	N/A

X Walk 1 X Slope (%)	3.2		X Walk 2 X Slope (%)	N/A	
N/A	Ramp inside XWalk1?	N/A	N/A	Ramp inside XWalk2?	N/A	
	Road Slope (%)	N/A	N/A	Clear Space?	N/A	
	Road X Slope (%)	N/A	N/A	Clear Space to XWalk (in)	N/A	
N/A	Any Obstructions?	N/A	N/A	Storm Grate/Utility Hazard?	N/A	
	Obstruction Type			Storm Grate/Utility Type		
		N/A			N/A	
			Yes	Surface Condition? (G/P)	Good	
10 mm

7F033IDIE 30IULIOII	
Possible Solutions:	Co
Remove & Replace Entire Ramp.	N/A
·	Ye
	N/A
	N/A
	N/A
	N/A
Surveyor Notes:	N/A
N/A	N/A
	N/A
	N/A
	N/A
PROW/ADA:	N/A
Not Found, R304.5.3	N/A
	N/A
	N/A
